Site Survey

4.1 Landscape and Visual Appraisal

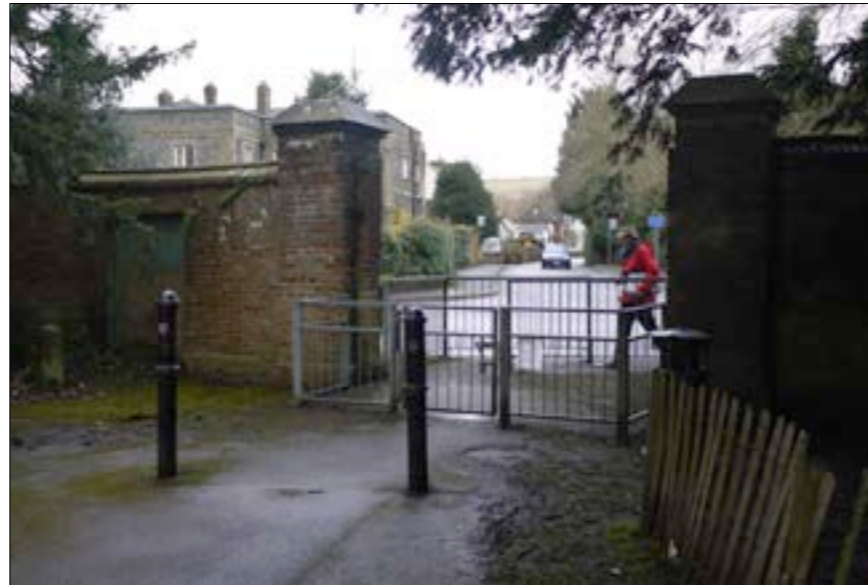
Plate 4.1: Temple Ewell (Lower Road entrance)

This entrance has a safety barrier and then a self-closing gate. The surface finish is generally worn and uneven and the turning area within the corral is too tight for a standard wheelchair and would be difficult for

medium and larger sized mobility scooters to use.

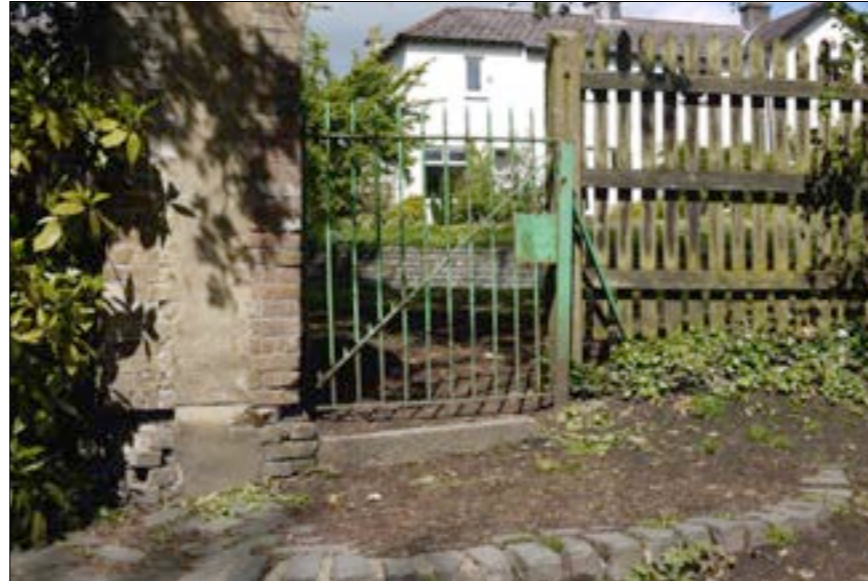
Plate 4.2: Pedestrian access Lower Road

This is an informal gated entrance, with no hard surface or dropped kerb approach on the highways side and a stepped compact earth surface finish on the Abbey site, which gets very muddy in wet weather, limiting access for a number of visitors.

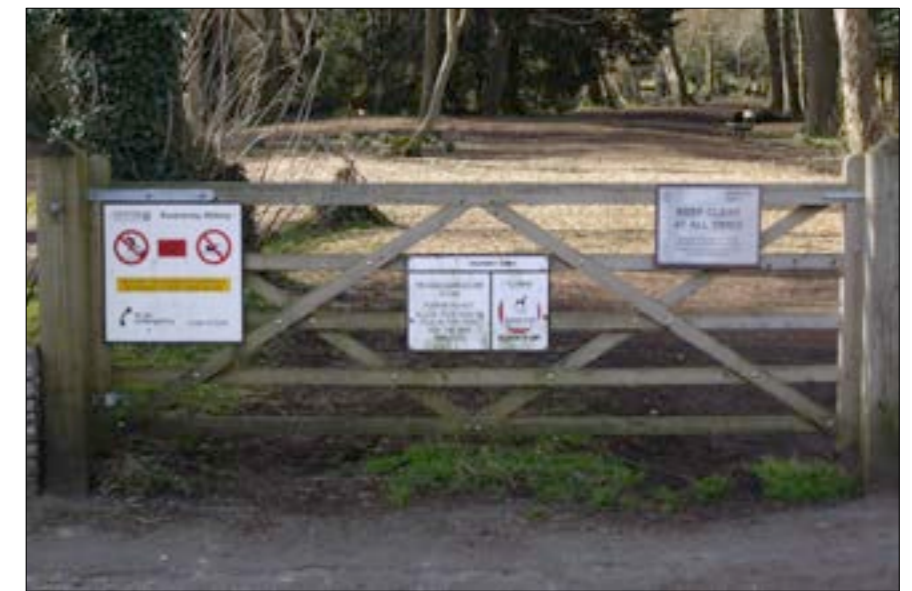
Plate 4.3: Minnis Lane entrance

The gate is latched and users have to reach over at high level to gain access, which is out of reach of wheelchair users, necessitating them to either be accompanied or to wait for a member of the public to assist. The clear opening width of the gates is good.

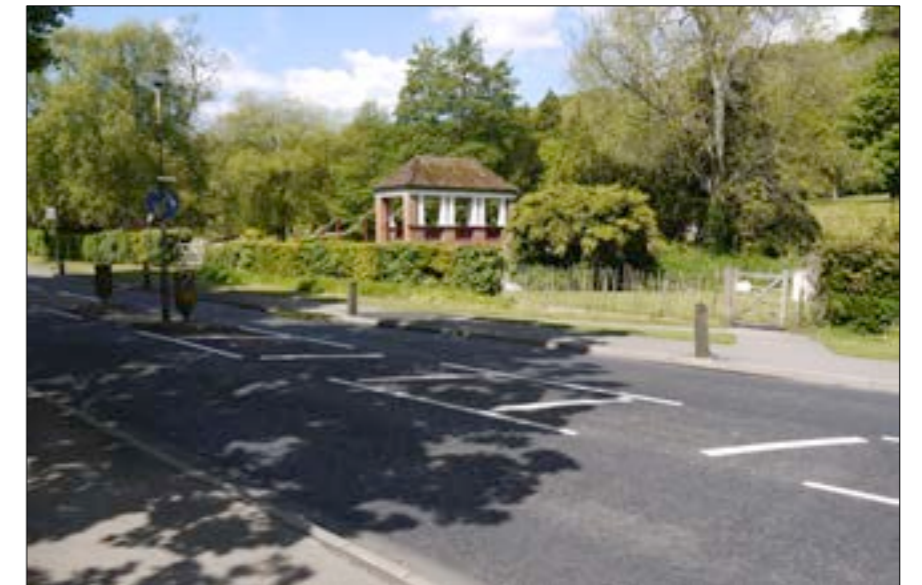
Plate 4.8: Russell Gardens main entrance

There is a wooden self-closing gate at the entrance. An informal sign (with pictogram) on the gate shows the location of the level access path, to the east, suggesting that visitors in the past have needed direction. This sign is 'homemade' and does not give distances.

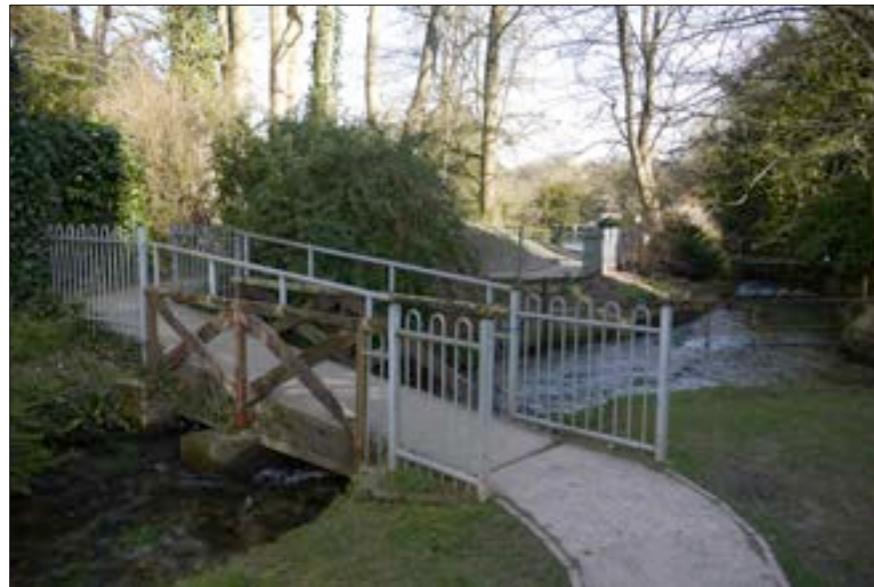
Plate 4.10: Bushy Ruff entrance

This link with neighbouring Bushy Ruff Park is hard surfaced and in places too narrow for pushchairs, wheelchairs or mobility scooters to pass.

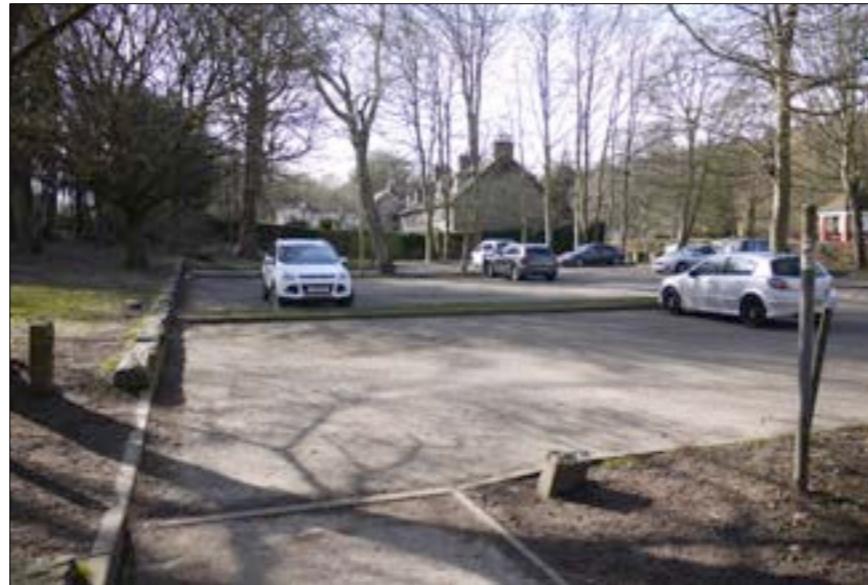
Plate 4.11: Western car park

This car park has marked out, but worn, parking bays but lacks disabled parking bays. The tarmac car park surface is damaged with potholes,

Information signs are presented in words only (no symbols) and with block capital text, which makes them difficult for some people to read and understand.

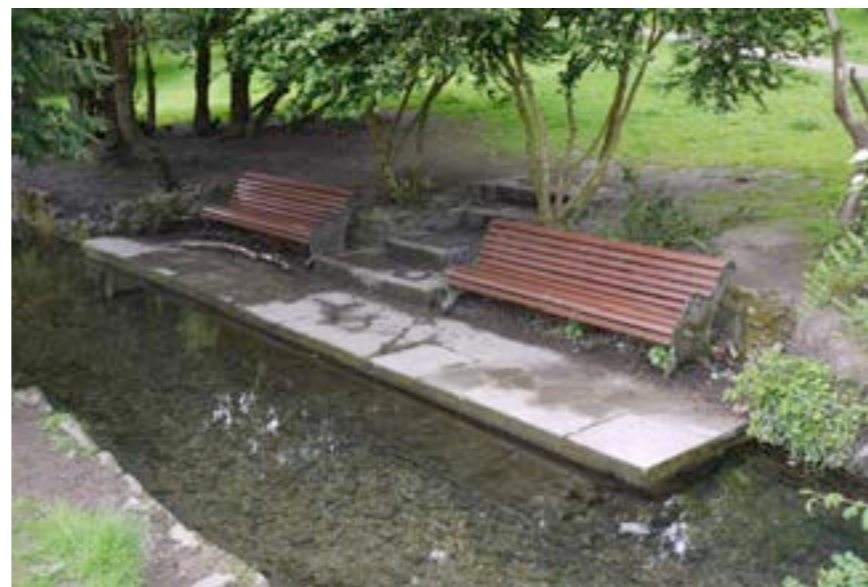
Plate 4.15: Sunken seating area

There are a number of sunken seating areas within the park where there are open culverts, all accessed by steps. These steps do not meet current design standards and may be difficult for some users due to lack of handrails and uneven risers. Surfaces vary from 'crazy' paving to compacted earth, and are usually uneven.

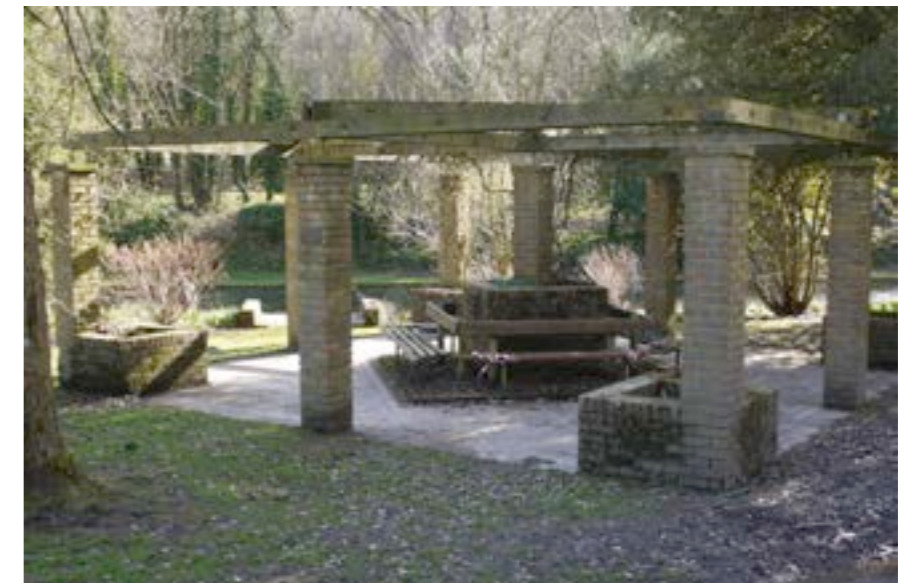
Plate 4.20: Gazebo

The gazebo has level access from the path by the tennis courts and stepped access from the path alongside the canal. The steps have no tactile warnings or handrails and the treads and risers are in poor condition. Access to the gazebo paved surface lacks a hard surfaced level route, but once in the gazebo the circulation space is good. The seats are in poor repair and have no arms to help people to stand and sit down.

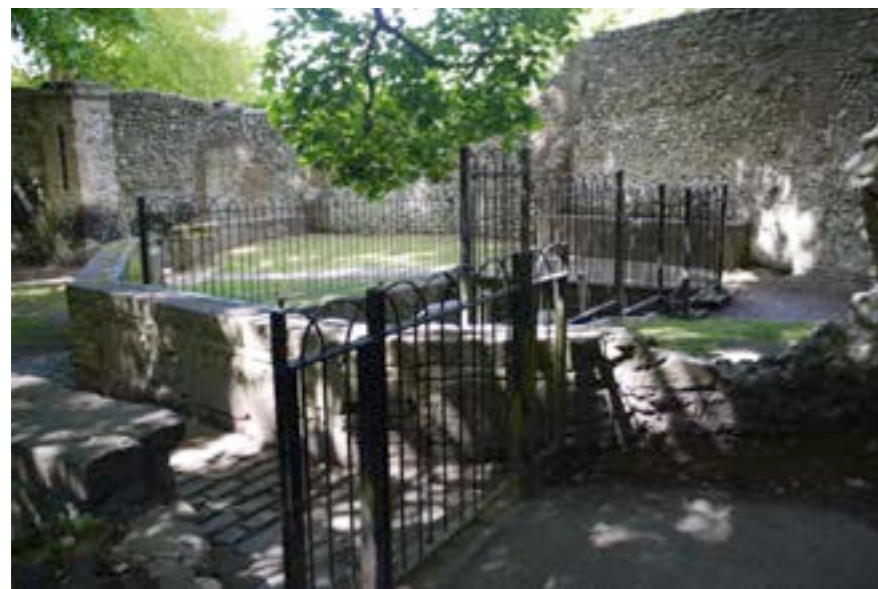
Plate 4.25: Walls around the old mill

Some areas of urgent work are needed around the mill ruins where repointing and recapping are needed to ensure the historic fabric does not deteriorate further.

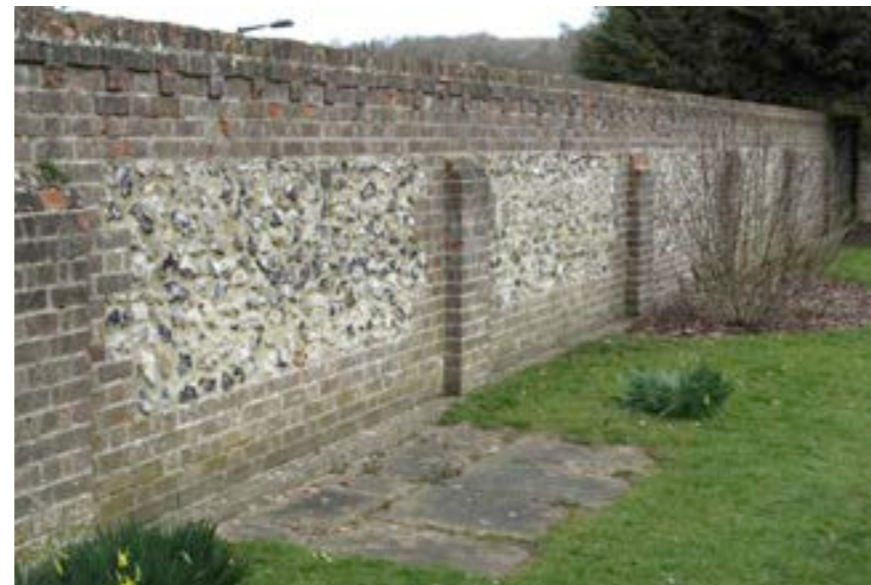
Plate 4.26: Section of wall showing flint panels

Generally the boundary walls are in very good condition. What damage there is, is related to the use of soft clay bricks in conjunction with a hard cement mortar and a poor masonry detail. In places, the half-rounded coping bricks have been replaced with flat capping brickwork, which has allowed moisture to infiltrate the upper sections of the brick panels, and in turn has led to spalling of facing bricks through frost action. There is an almost continuous loss of mortar along a horizontal line through each panel.

The flint panels are in excellent condition and exhibit very little damage.

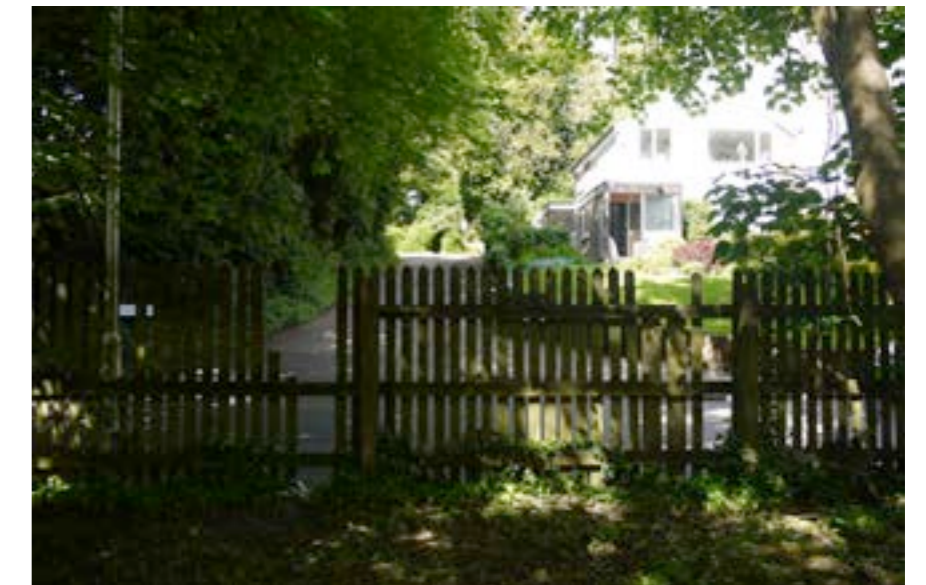
Plate 4.27: Lower Road palisade fence

The boundary along Lower Road consists of a timber palisade fence with three timber rails and concrete pillars, approximately 1.8m high.

This provides a fairly open barrier to the road and busy traffic and is not robust enough to deter local residents from creating their own way into to the park opposite Chisnall Road.

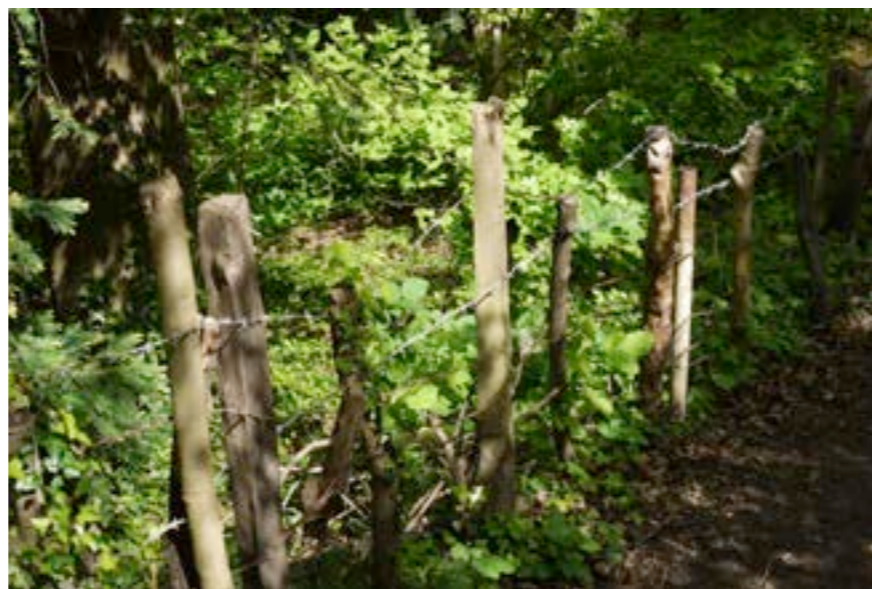
Plate 4.31: Barbed wire fence protecting neighbouring housing

Along this boundary is a cleft pale and barbed wire fence that runs immediately alongside the woodland path which links the lower areas of the parkland with Frandham Wood. The barbed wire is particularly unpleasant and hazardous alongside this narrow path, which runs up the steep incline.

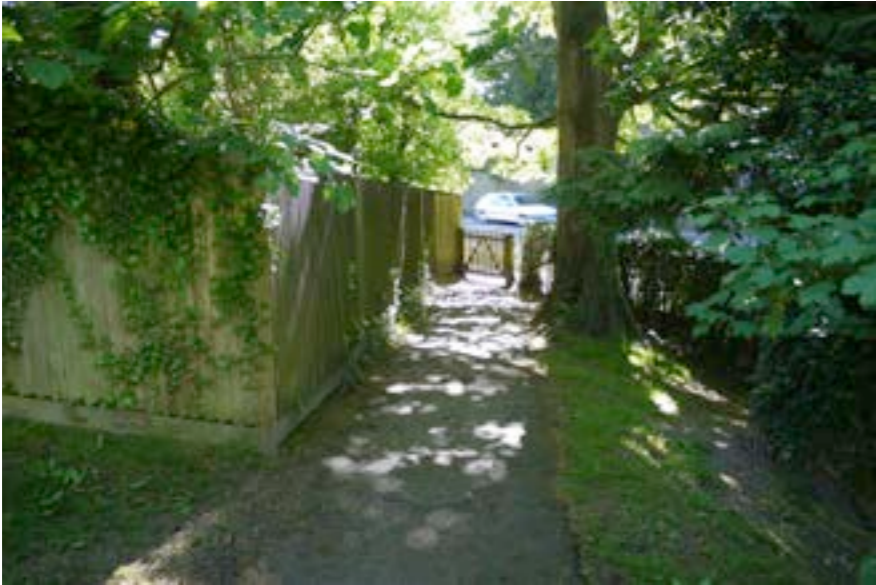
Plate 4.34: B11 Close board fencing at disabled access entrance

The boundary with the houses built in the former grounds of Kearsney Court consists of a 1.8 - 2m high timber close board fence. Its alignment makes the path that provides universal access into the gardens, too narrow for people with buggies or wheelchairs to pass.

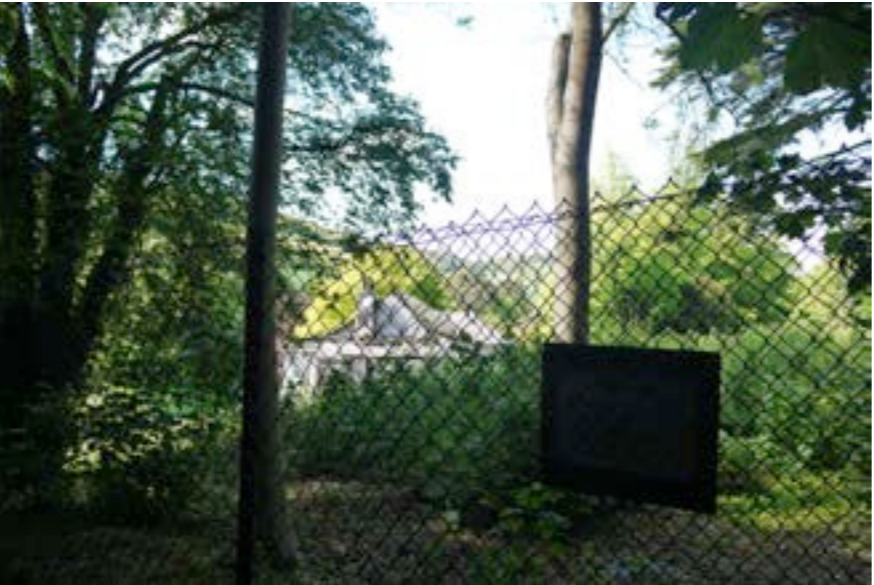
Plate 4.37: B14 Wire mesh fence on western boundary

Chain link fencing approximately 1.8 – 2m high separates the park from the adjacent site of Bushy Ruff House. Some sections have been damaged to create access, but most of the fence is in reasonable repair.

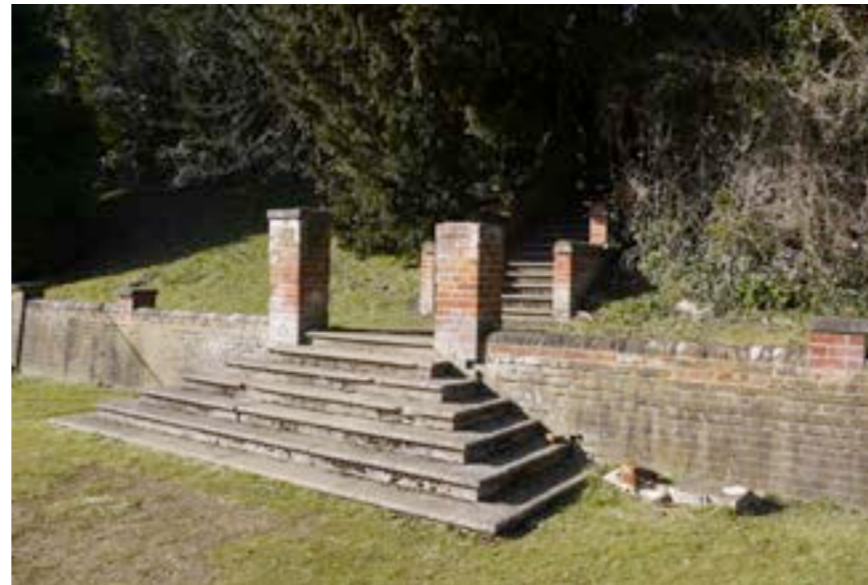
Plate 4.38: Steps to Bastion

Steps that form the lower and middle flights appear to be suspended over a void. Construction is believed to involve cross supporting walls with the concrete steps bearing onto these walls and onto the side walls, as well as onto each other down the flight of steps. The concrete steps are generally level and reasonable condition, but their supporting structures are vulnerable and need to be investigated.

The brick side walls of the middle and upper flights are capped with semi-circular coping bricks, and the brick piers, which have been reduced from their original heights, are capped with concrete coping stones. The condition of the masonry particularly for the upper steps is poor and in need of repair.

Coping stones are missing and / or broken on several of the piers as well as a segment of the side wall of the upper steps. Coping bricks and stones contribute to the water shedding capabilities of the walls, and thus generally maintain the fabric of the masonry below and they should therefore be reinstated.

There is a large tree very close to the upper flight of steps; in some areas the large branches are only 100mm from the steps. Surprisingly, this has caused no visible damage to the steps themselves. However damage could be caused by large branches moving or dropping, and by

Overgrown the trees and vegetation should be removed, in conjunction with masonry repairs, which will greatly improve the condition of the steps, and thus their lifespan.

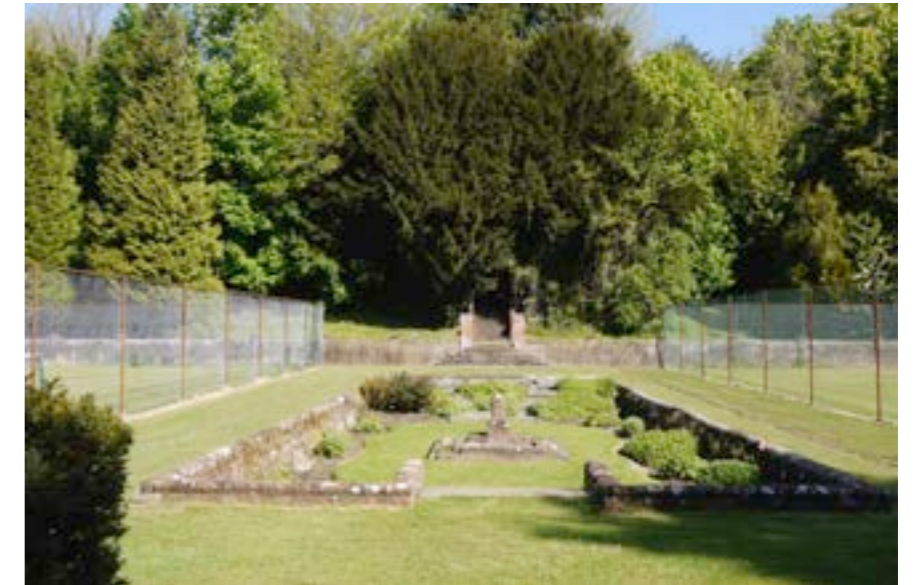
Plate 4.39: Lily Pond

The pond walls are in need of masonry repairs, which should be undertaken as soon as practical to limit further deterioration.

If the pond is to be reinstated as a water feature, then more investigation of the condition of the concrete walls and slab is needed, to determine water tightness or the extent of repairs / reconstruction needed. The sunken garden feature will have to be cleared before this can be done.

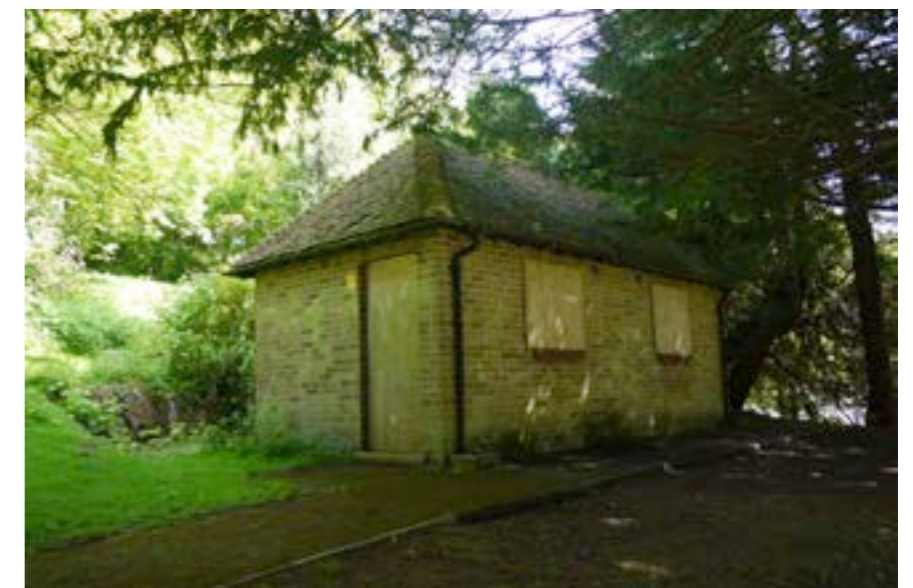
Plate 4.40: Disused toilet block

The gutters are in need of clearing and maintenance. On the south elevation, there is a leaking gutter that has caused damp in the adjacent brickwork. There are also some slipped and broken tiles on the roof, which requires minor repairs.

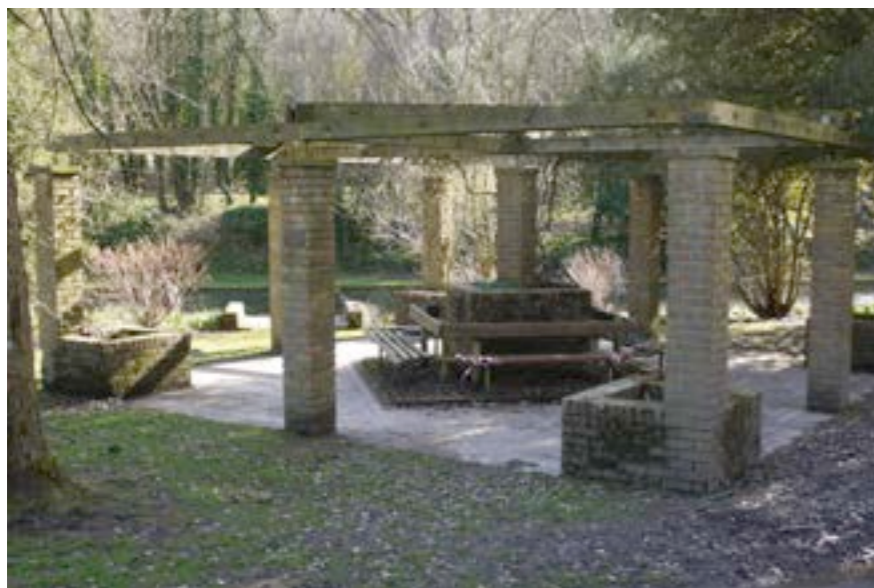
Plate 4.41: Gazebo

The modern masonry has no defects of note. Bolts that fix the timbers together may require replacement in time, but at this stage the corrosion that they show is only superficial. Bench repairs or replacements are also needed.

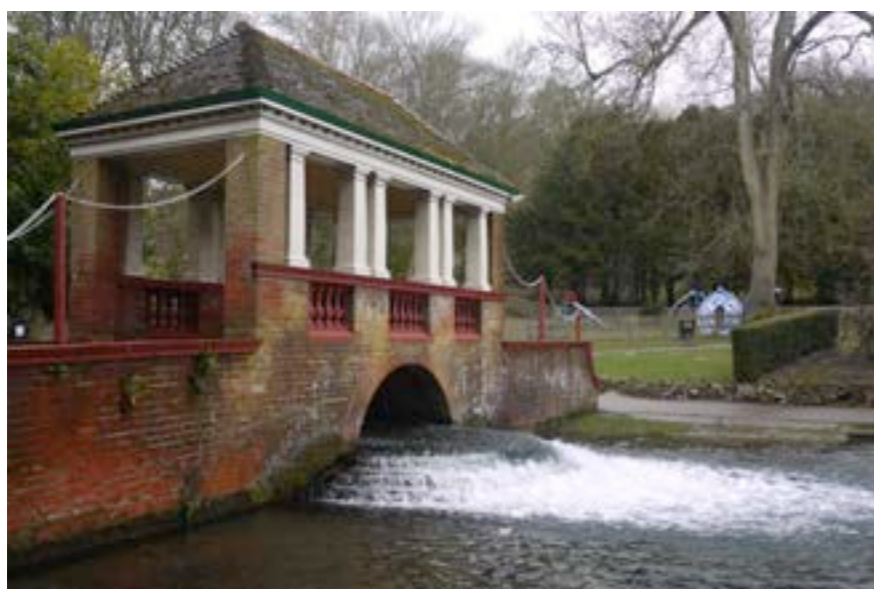
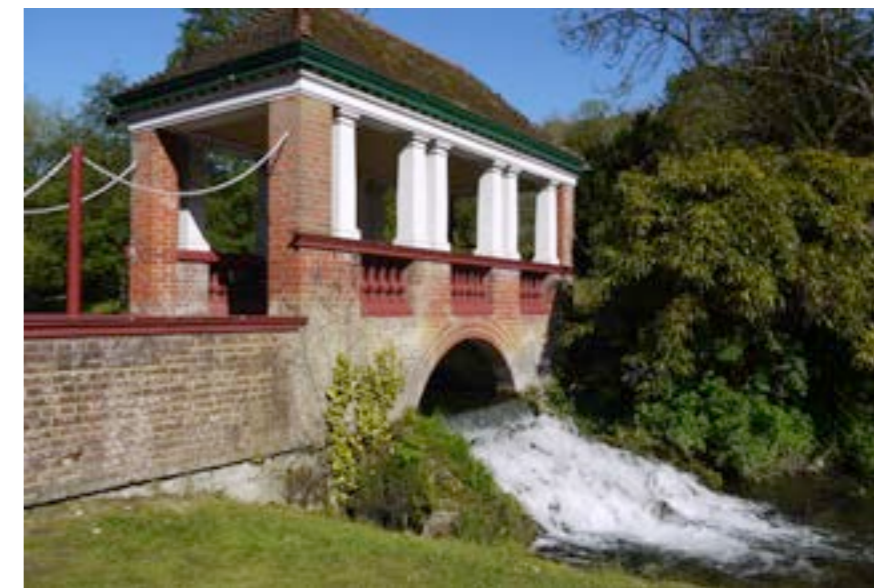
The bridge pavilions are formed of brick walls with a brick arch over the canal. The bridge deck forming the walkway is of concrete, as are the steps and the coping stones. Some of the steps have been replaced with in-situ concrete repairs which lack the curved nosing of the originals, and which has exposed aggregate.

Both of the bridge pavilions show signs of past settlement. This may have been caused by water flow eroding the soil. Poured concrete below the western bridge and on the riverbed in this area, seems to have been used as a remedial method to prevent further erosion. The eastern bridge pavilion seems to have a concrete footing, but it is not clear if this was a remedial measure or part of the original structure.

Generally, the masonry of all three pavilions is in need of repointing, and repairs to the coping stones are required. Restoration work, including replacing clumsy and inappropriate repairs with work that matches the original, for example, to fully restore the flights of steps, is also desirable.

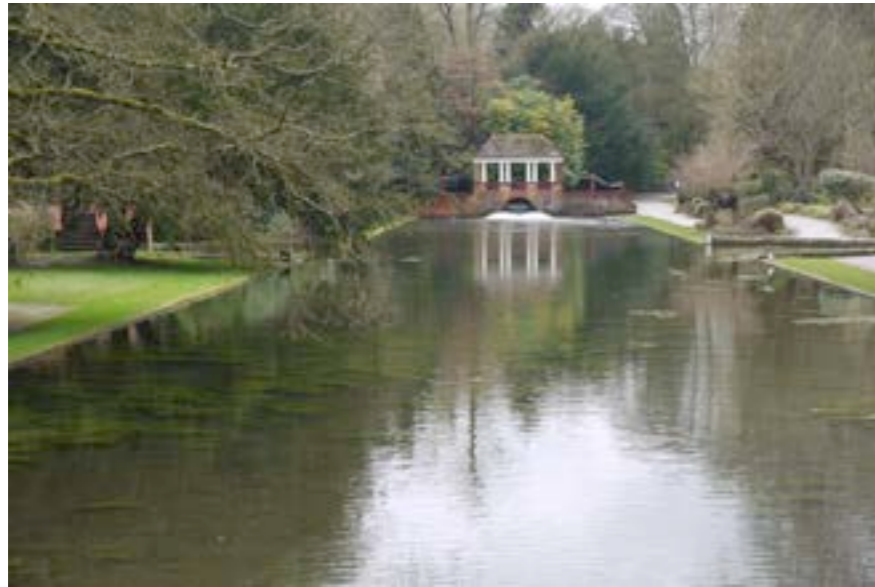
Plate 4.45: Canal

There is historic and anecdotal evidence that indicates the canal periodically fails to retain water, including an incidence of the pond draining within 24 hours following the 2007 earthquake.

There are multiple factors that could result in the pond draining, either individually or in combination including cracks in the pond base, poor pond construction, or degradation of the concrete base, allowing water to drain through the permeable chalk underneath; and imbalance in flows, if the drawdown is passing a larger flow than water entering the pond from the upstream river then the pond will drain.

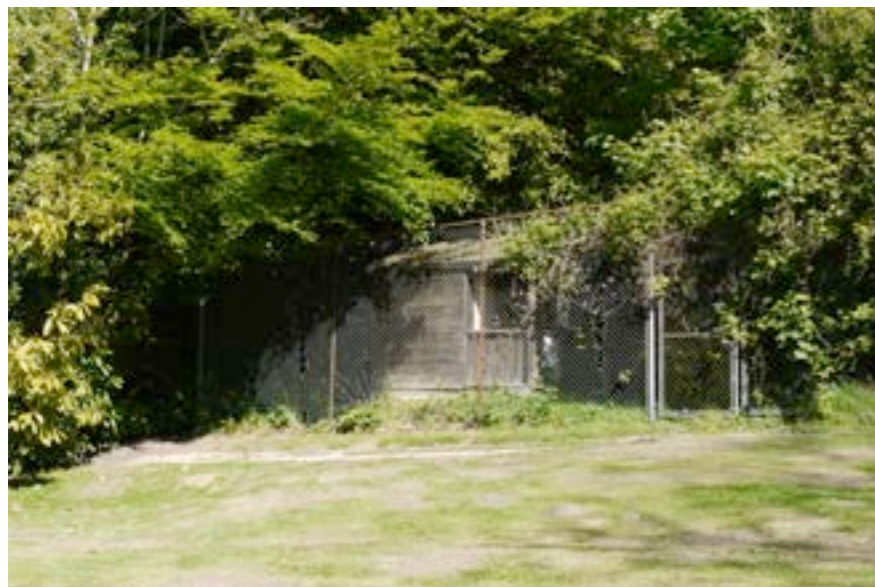
Plate 4.46: Derelict hut

This is a derelict timber hut, sited within the shrubberies to the east of the tennis courts, which was used as a pay point for tennis and pitch and putt. It is now redundant and should be removed, together with the unsightly chain link fence and gate.

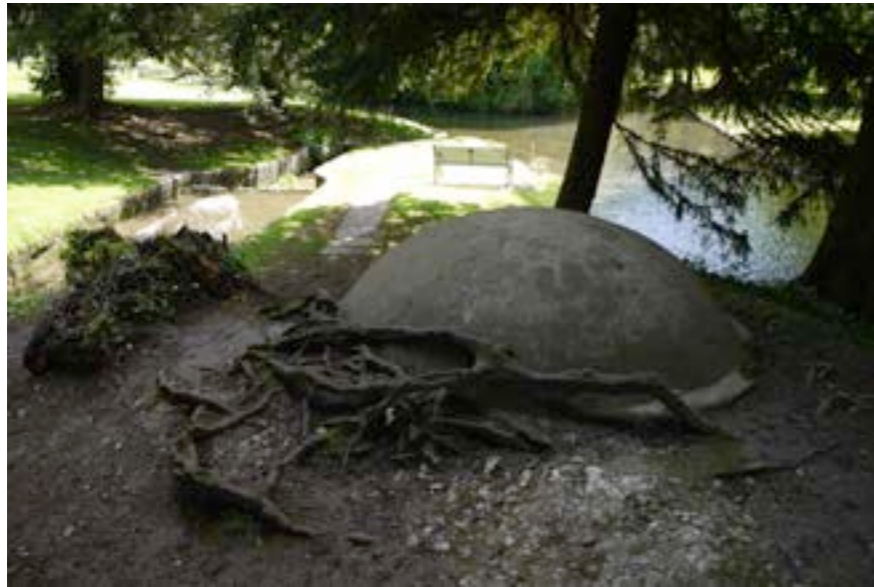
Plate 4.50: Dome of the Pump House

The concrete capping of the pump chamber is broken in a small area at the base of the dome. Bricks are exposed in this area and have weathered. There is also some minor pattern cracking in the concrete in this area.

Generally, it seems to be in a sound and stable condition. Minor superficial repairs to the render are needed. The condition of the interior could be inspected with a boroscope through a small drill hole, and is recommended if any further signs of deterioration are seen on the outside.

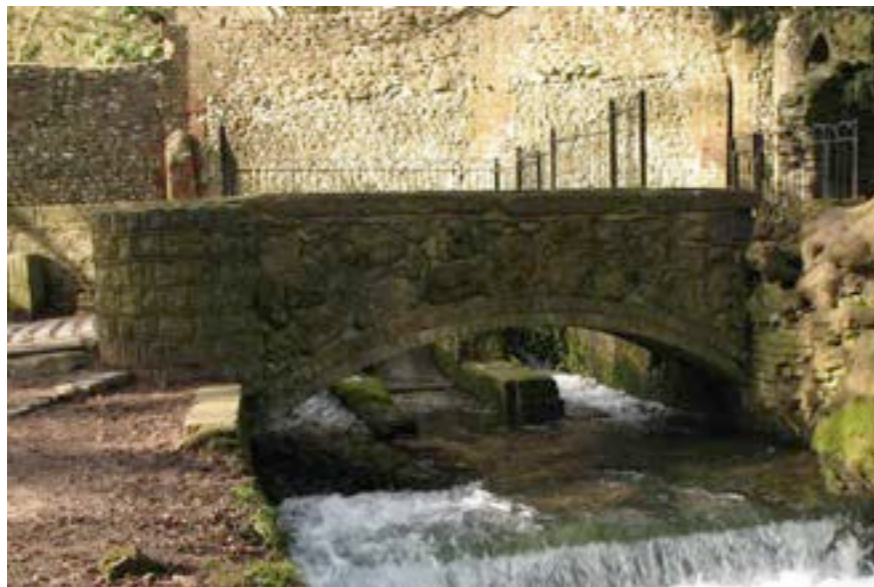
Plate 4.51: Pump House Bridge (TMP photograph)

At the base of the south elevation of the west bridge wall, there are deep open joints in the masonry. Consolidation and repairs are needed, including repointing with an appropriate mortar.

heritage mortar. Roots of a large tree on the north river bank are causing movement in the brickwork; the bank itself appears stable. Repairs of this area are not practical unless the tree is removed.

Handrails are loose and should be re-fixed.

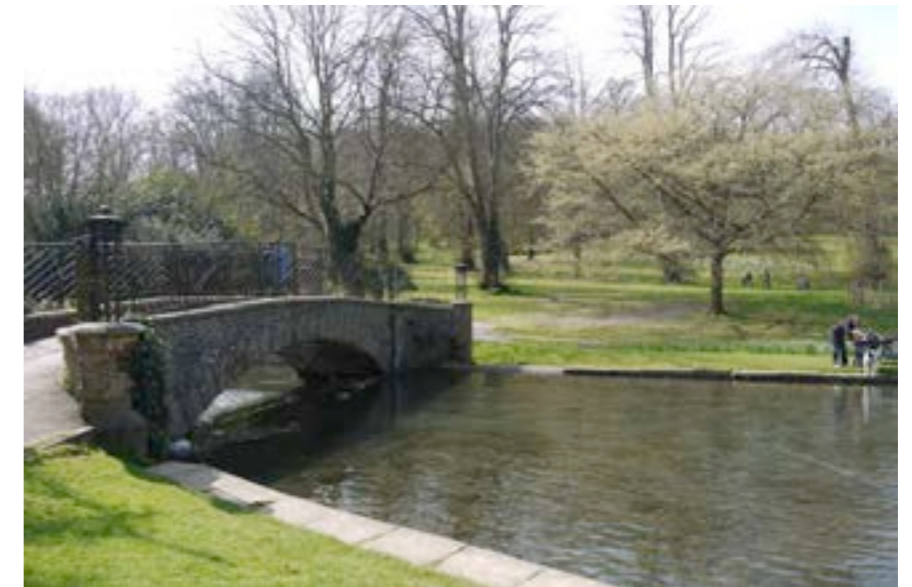
Plate 4.53: Bridge

The footpath over the bridge is paved with asphalt, which appears to be in reasonable condition. This may have been built up over time, as the parapet wall is quite low in relation to the path.

The bridge is in fair condition, but is in need of masonry repairs to several areas; these repairs are not considered urgent but will prolong the fabric and prevent further deterioration.

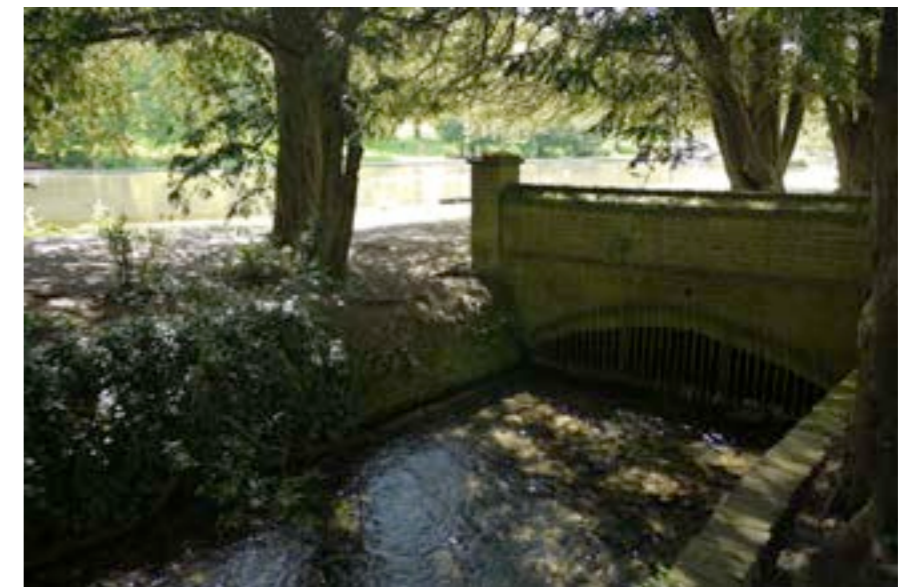
Plate 4.54: Arch over river

Masonry below the water level was not inspected. There are no signs structural movement or other vulnerabilities, but they should be inspected if coffer dams are employed for re-pointing under the arch, or if the lake is drained down at any point in the future, and any necessary repairs should be carried out at the same time.

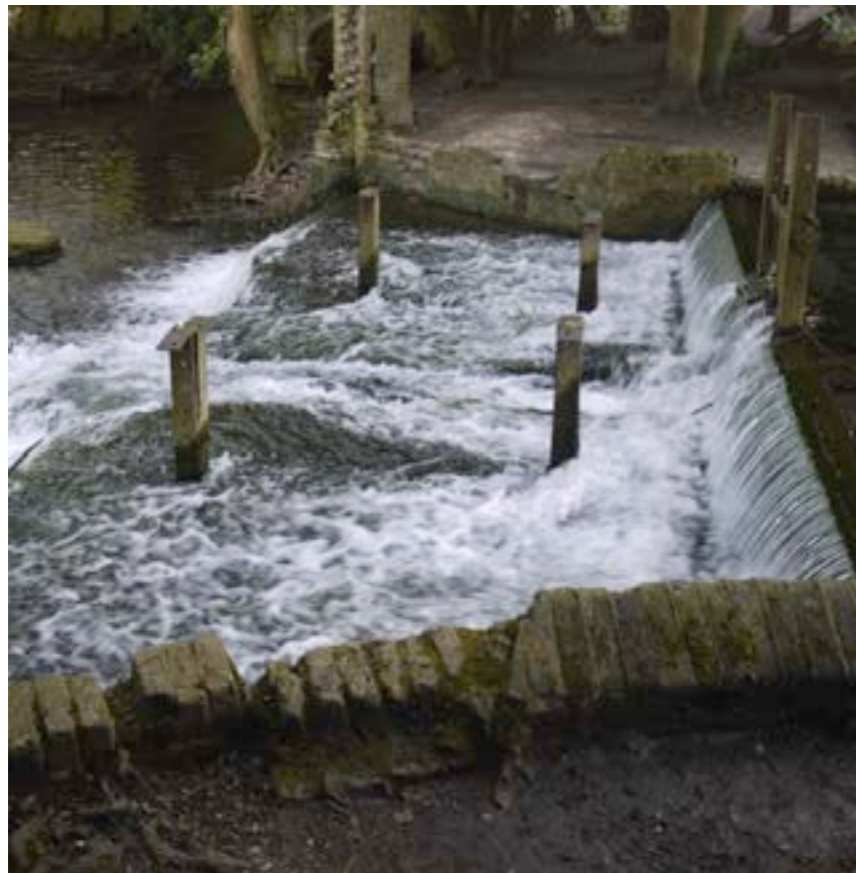
Plate 4.55: Remains of the eye catcher

There are open joints in the coping bricks, where vegetation has penetrated the brickwork. There are also missing bricks around the northern pier. The underside of the arch shows signs that water has penetrated the masonry and is eroding the structure.
