HISTORIC STRUCTURES AT KEARSNEY ABBEY, RIVER, DOVER

Revised December 2016

The present historic building survey was commissioned from Canterbury Archaeological Trust (CAT) by Jon Winder, Kearsney Parks Project Manager for Dover District Council (DDC), in November 2016. It is intended to provide a record of several historic structures affected by proposed enhancement and restoration works at Kearsney Abbey Gardens, Alkham Road, Dover (NGR: 628740 143795).

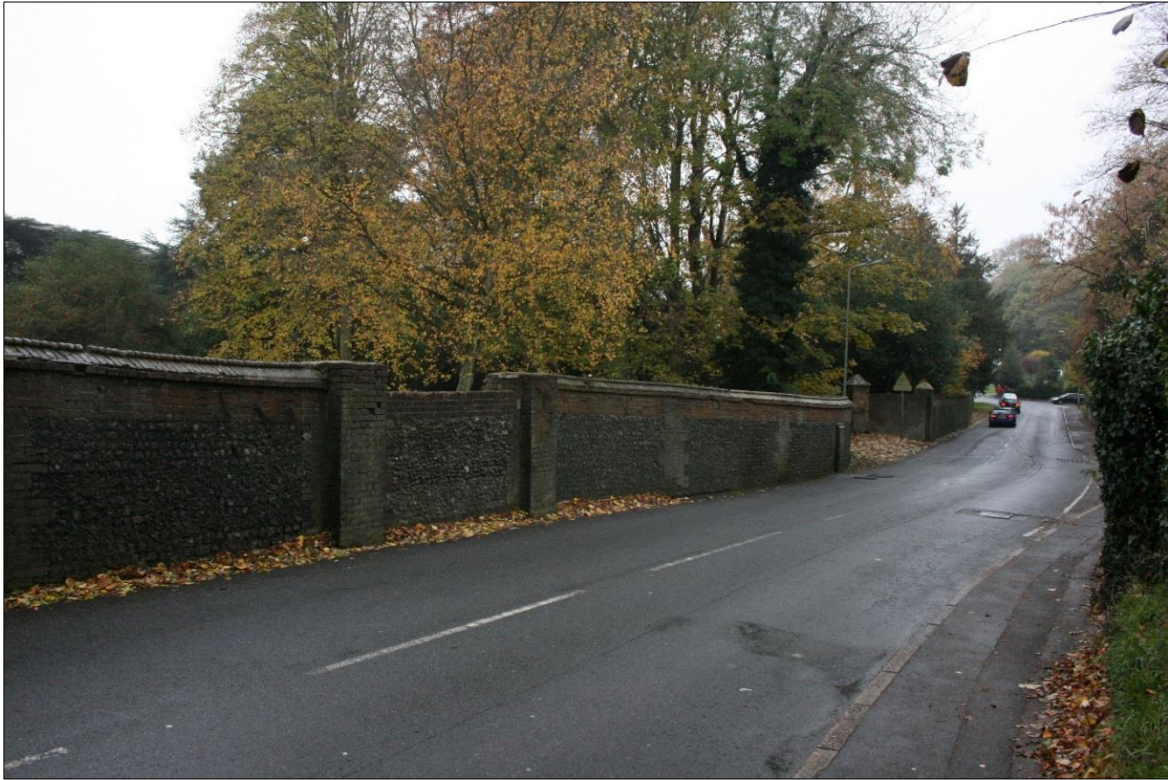
Part of the Alkham Road boundary of Kearsney Abbey, looking south-west.

Kearsney Abbey was enclosed, around much of its perimeter, by a flint and brick boundary wall, much of which survives. Coursed knapped flint is laced, at intervals, with the usual pinkish yellow brickwork. The head of the wall comprises several courses of brickwork, surmounted by a shaped-brick coping with a roll-moulding at the crest. Curved portions of wall, and sections flanking gateways are, in places, entirely of brickwork. The wall was reinforced, at changes of alignment and elsewhere, by square brick piers with shallow pyramidal stone caps – hollow-moulded where they project over the brickwork.

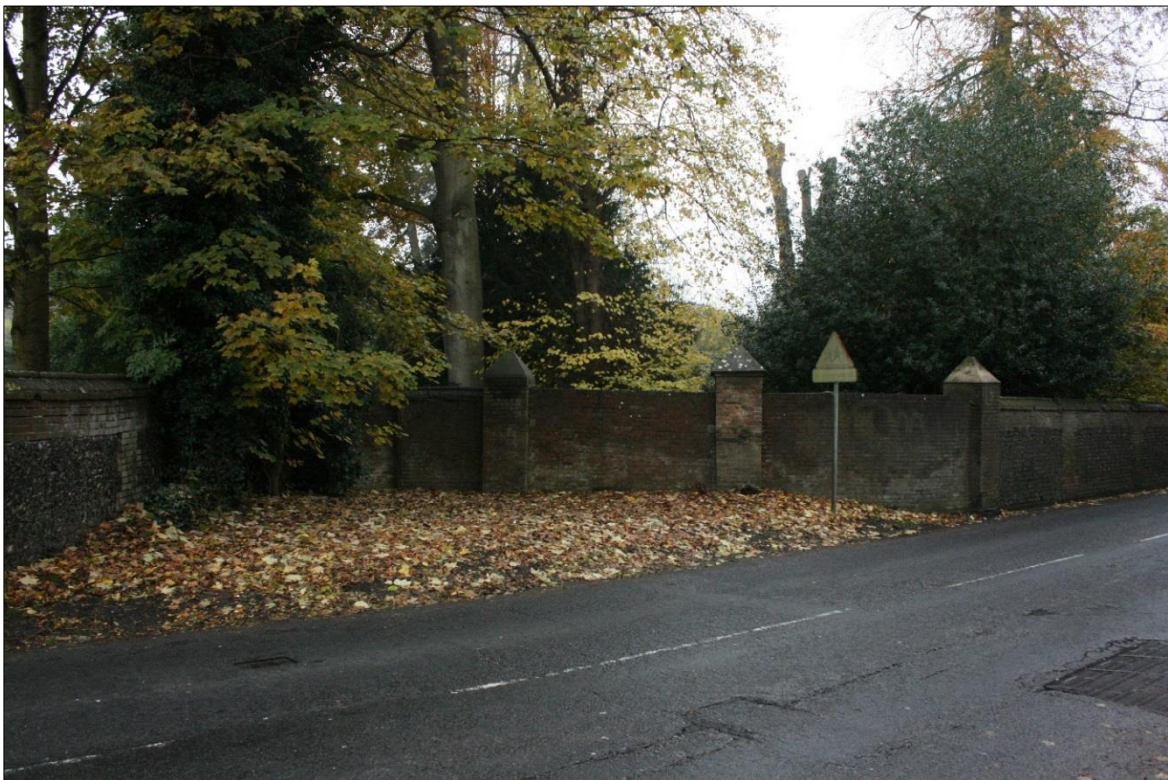
The original main entrance to Kearsney Abbey from the Alkham Road, looking south-west.

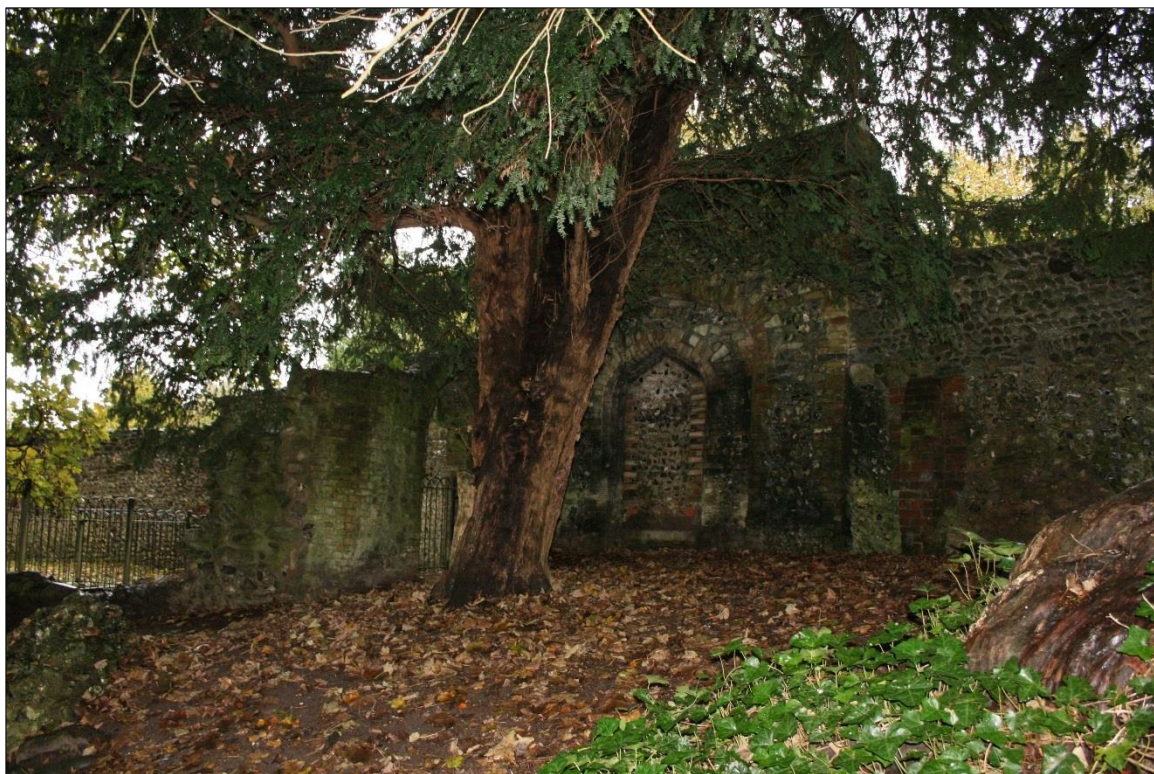
Ogival arch set within a four-centred arch in the Alkham Road boundary wall, east of the ‘mill’.

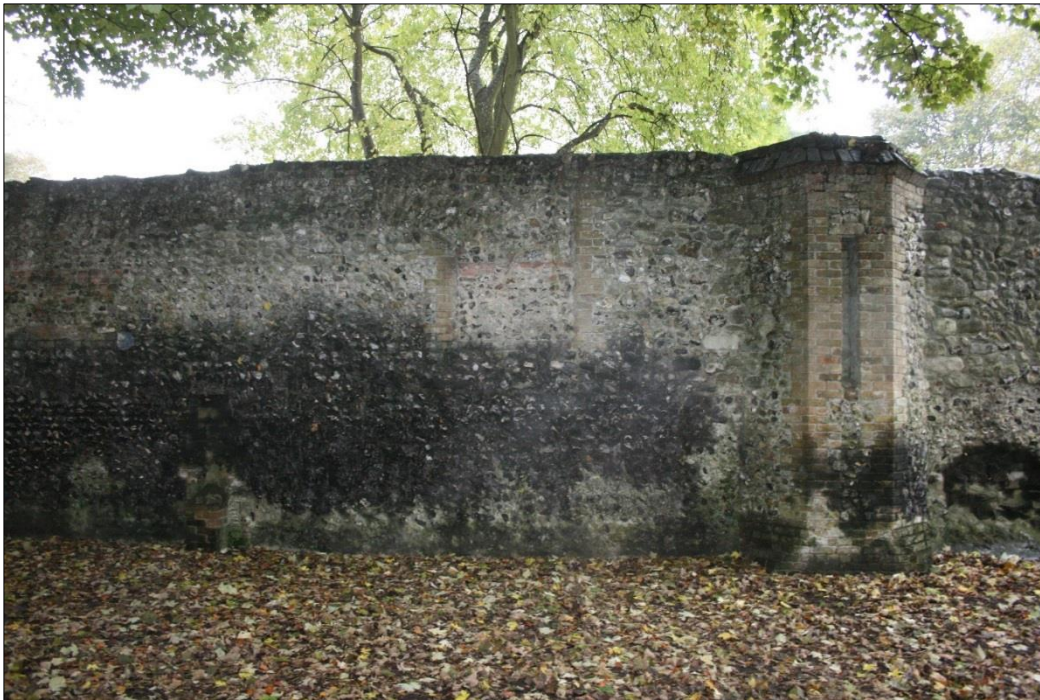
Blocked 'windows' and an octagonal turret to the west of the 'mill'. These apparent window apertures do not appear ever to have belonged to any building, and may well have been built as 'ruins.'

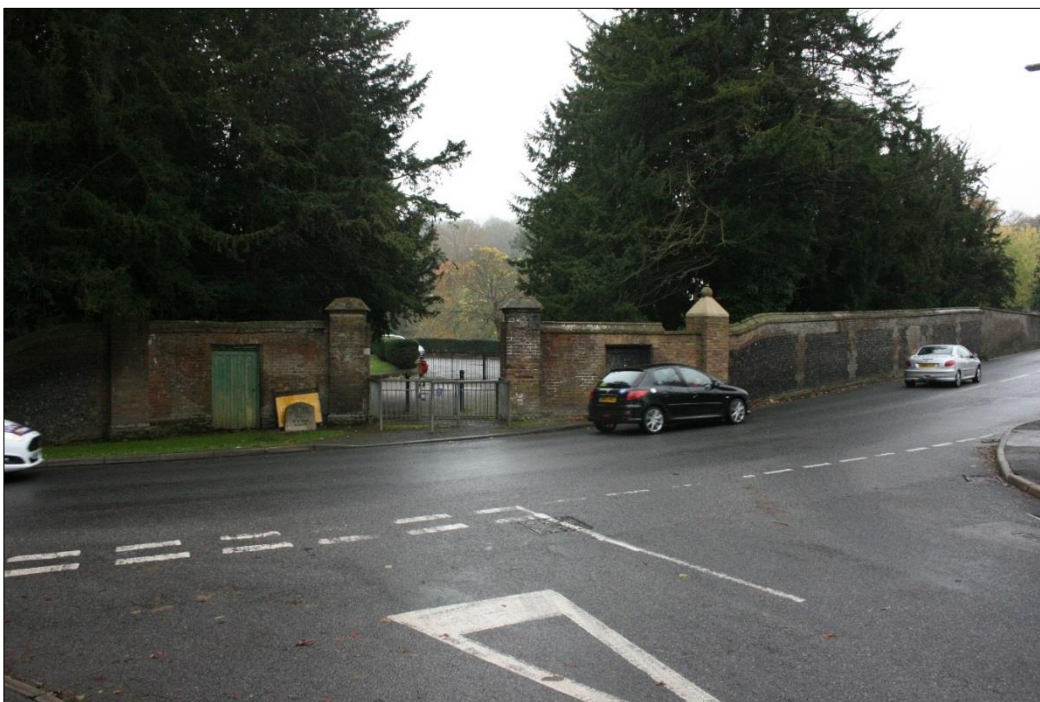
The present entrance from Alkham Road, opposite Lower Road, Temple Ewell.

The gatepiers with ball finials mentioned in the listing evidently belong to the present entrance opposite Lower Road Temple Ewell, flanked by a pair of timber doorways. This, however, may be a mid to late nineteenth-century alteration; it is not evident in the tithe map of 1838, but features in the First Edition *Ordnance Survey* of 1874. The original main entrance to the grounds, lay about a hundred yards to the east, attended by an entrance lodge.

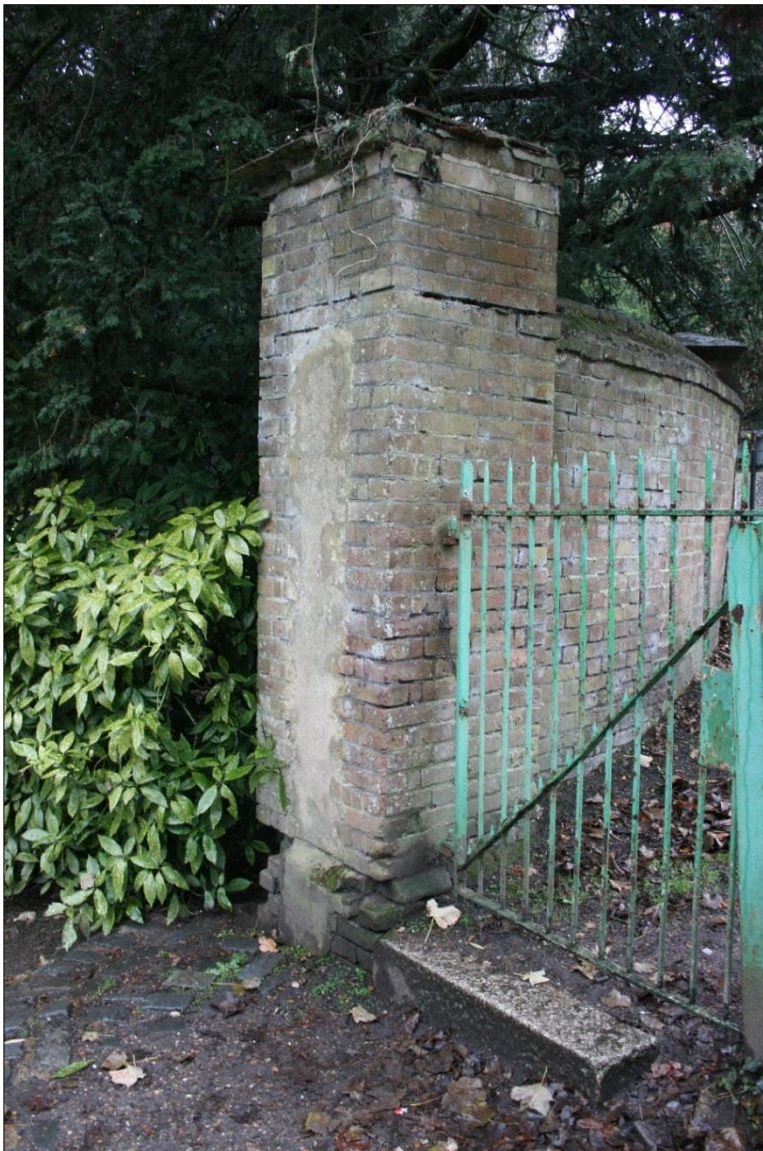
However, it is clear, from a scar in the south face of the last surviving buttress, that the Kearsney Abbey boundary wall formerly continued southward, and along the early nineteenth-century dam at the lower end of the Abbey Lake, to join the north-west corner of the kitchen garden. Footings, and other remains of this stretch can still be seen along much of its length and, although it has long been demolished, its line still features, unbroken, in *Ordnance Survey* data.

Southernmost pier of the surviving Lower Road boundary wall, showing the scar from the demolished continuation.

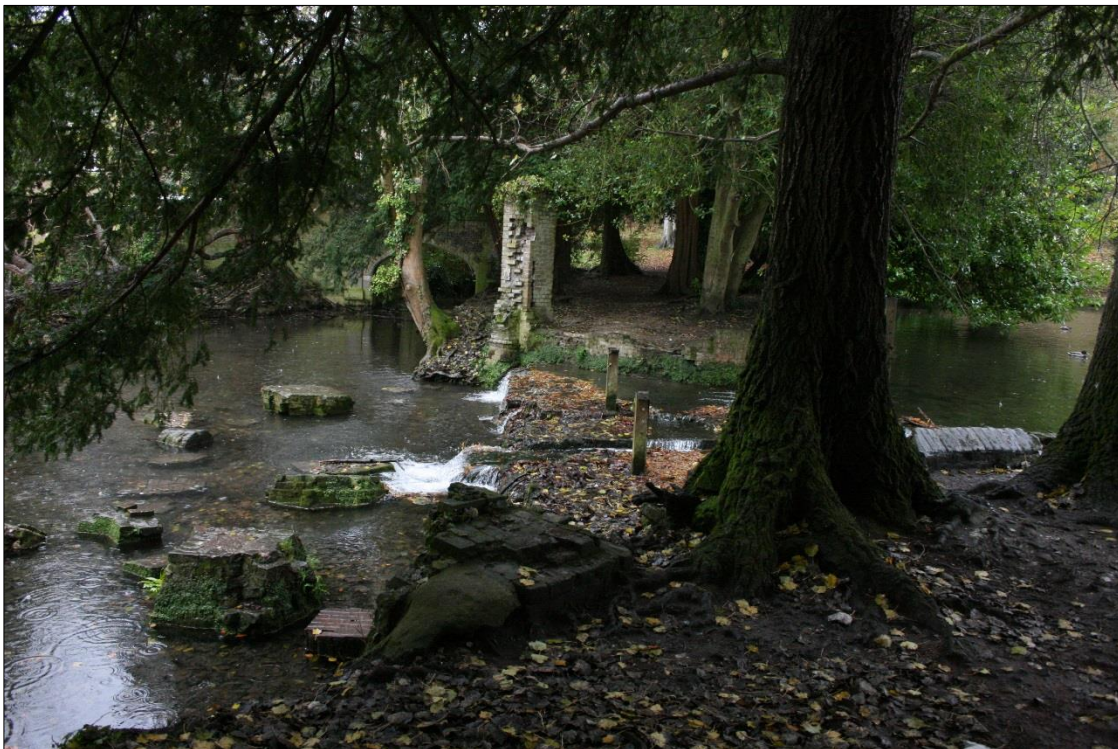
The southern end of the former millpond boundary, looking south.

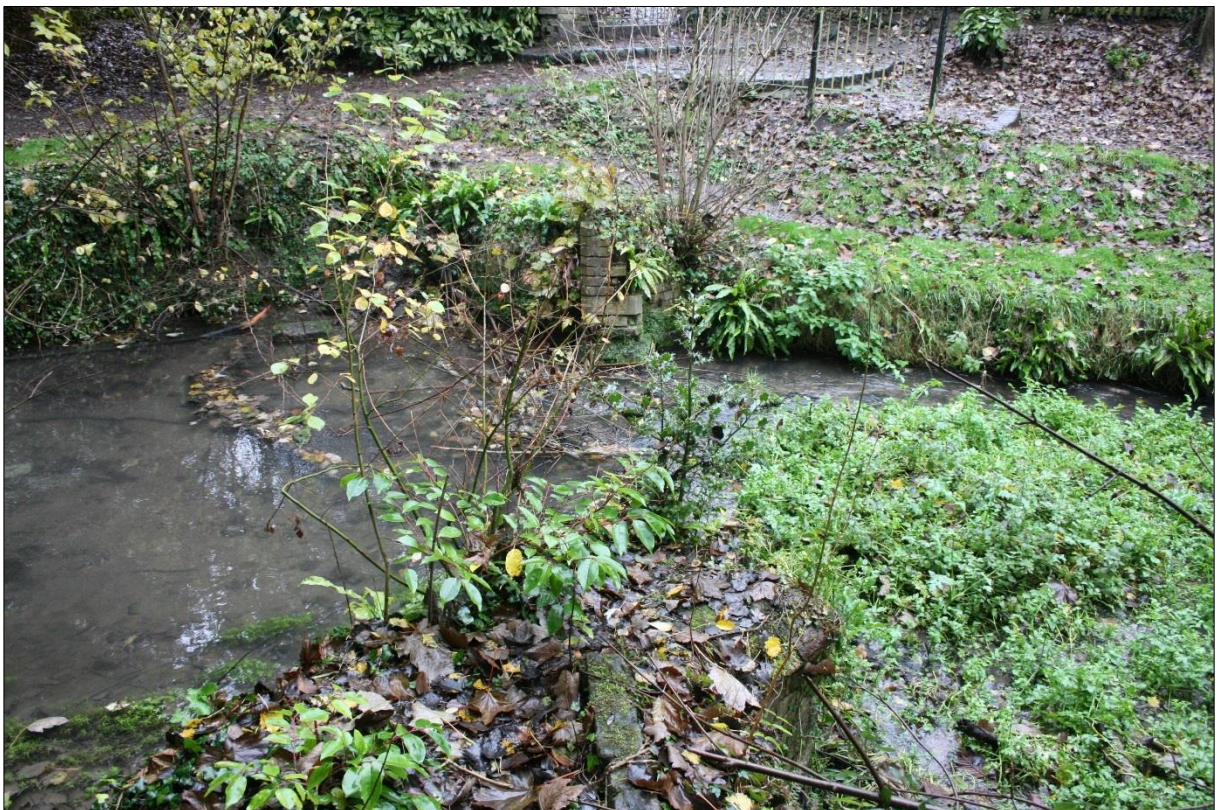
Remains of the arch over the northern branch of the River Dour, looking north.

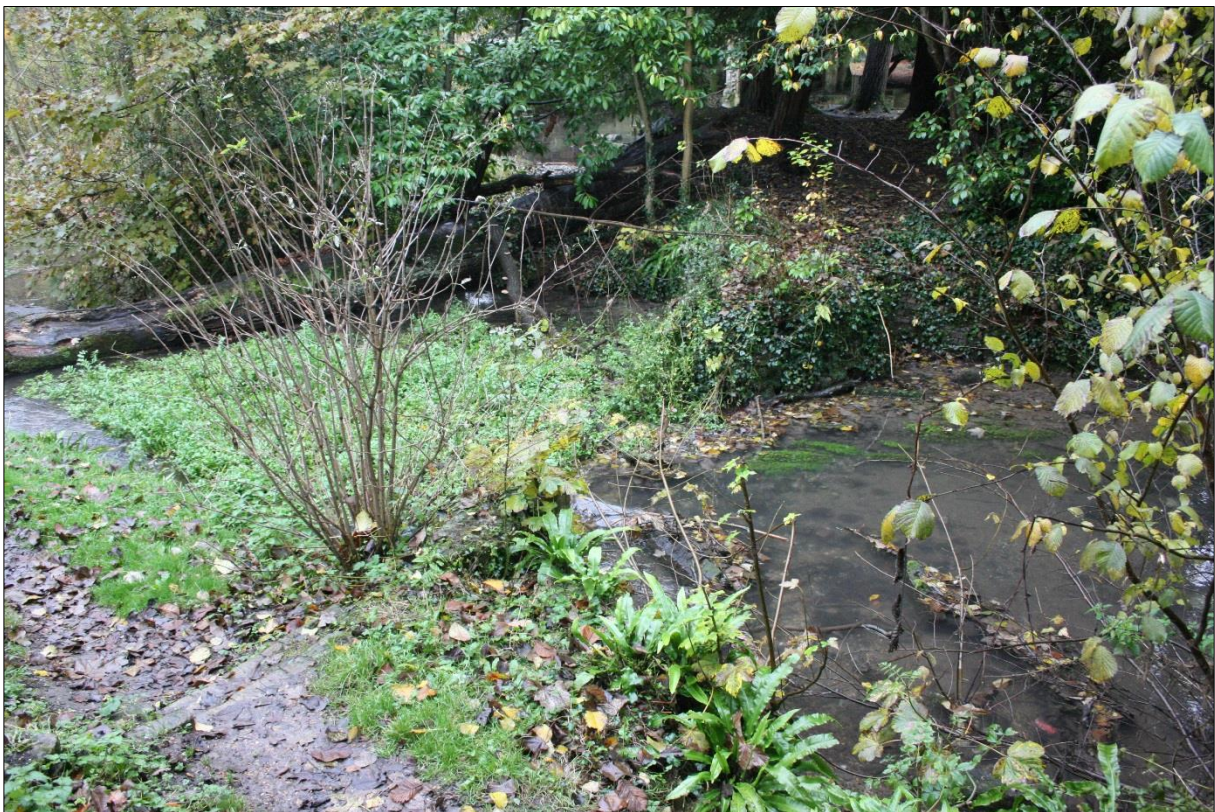
Remains of the arch over the northern branch of the River Dour, looking south.

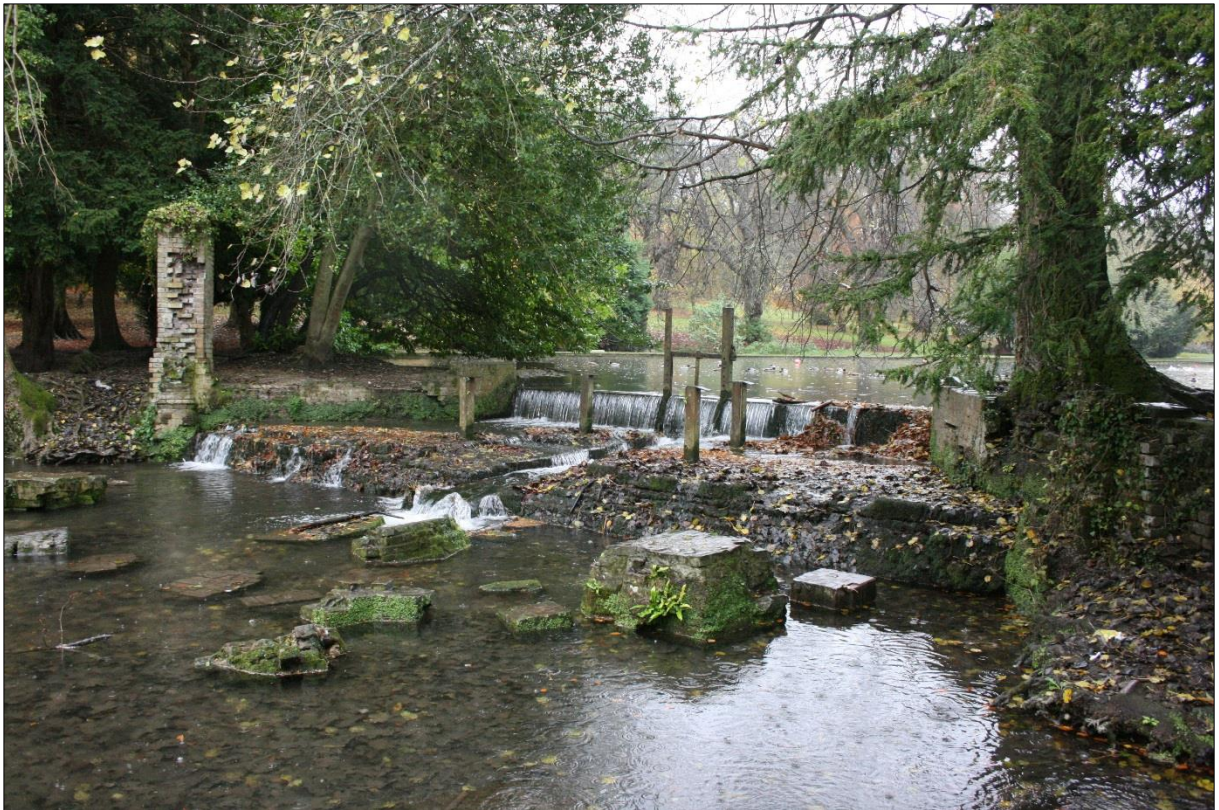
Remains of the arches in front of the weir at the lower end of the lake, looking south-west.

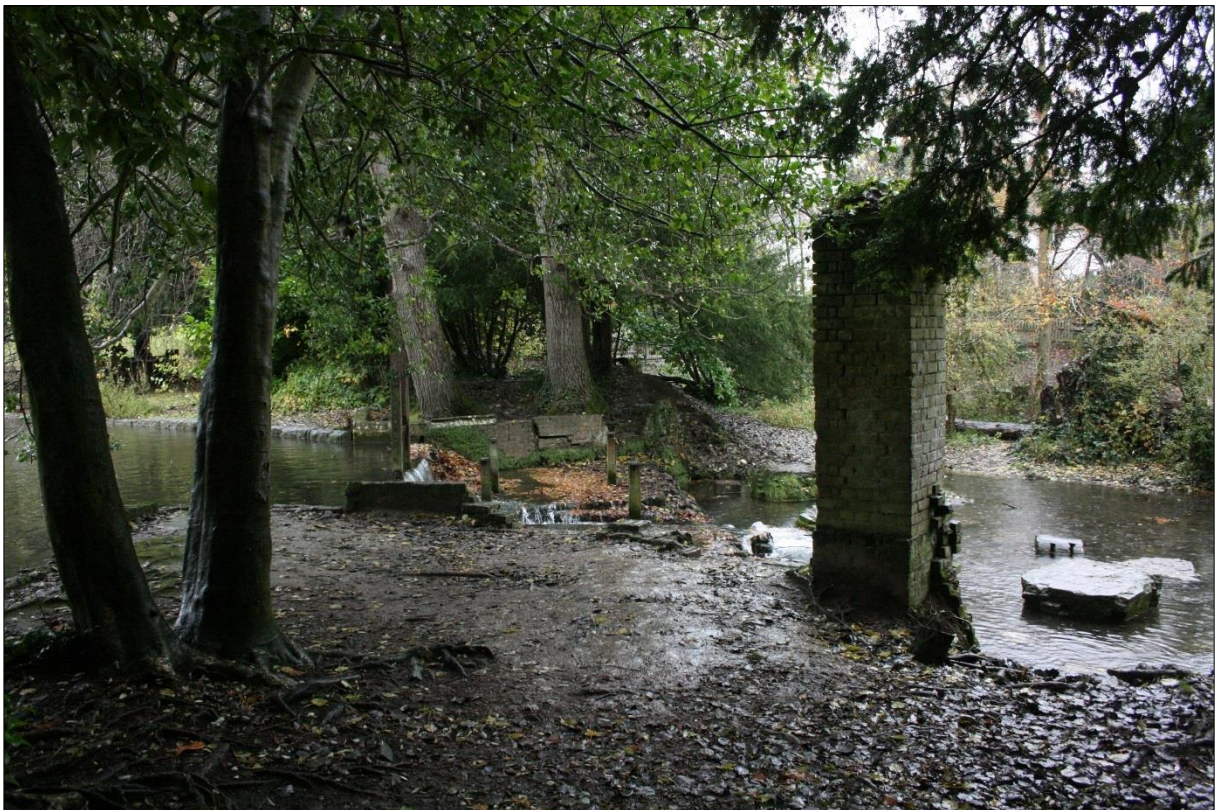
The same, looking north.

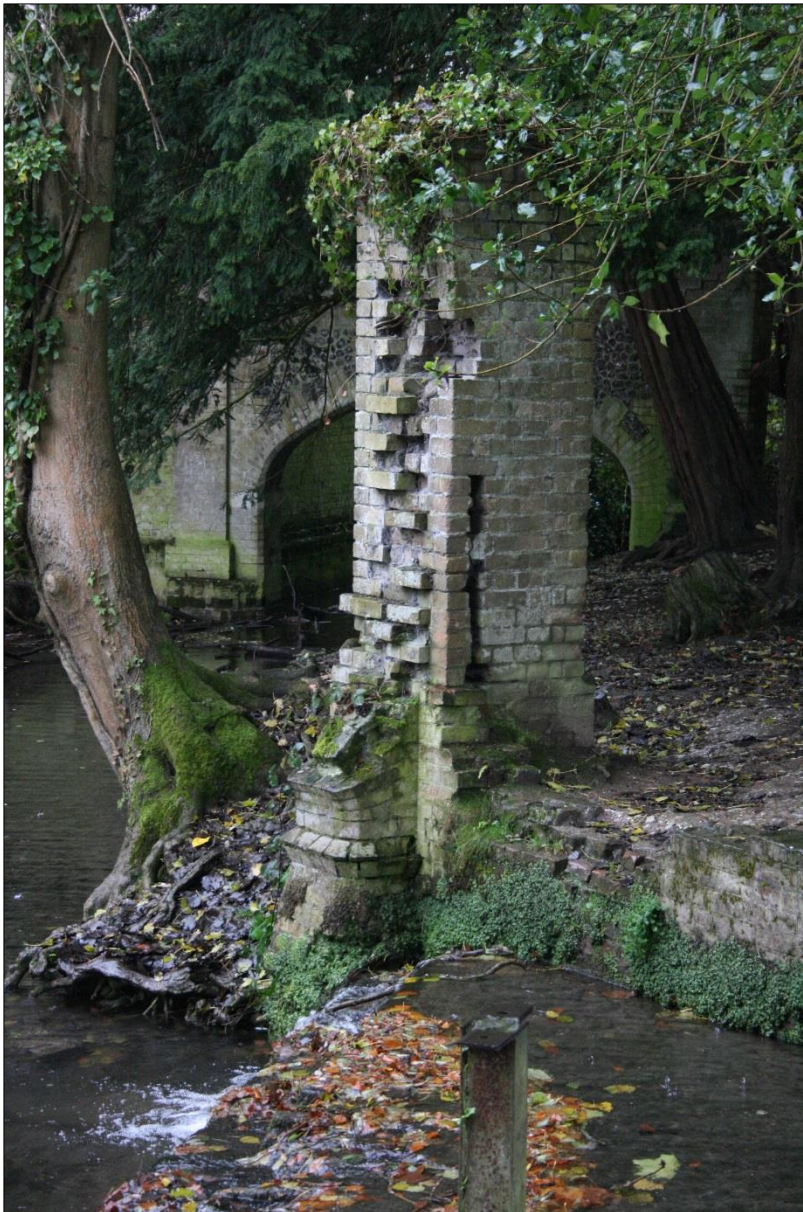
The southern pier, showing the springing of the outer arch, the bricks which keyed the pier into the flint superstructure, and a slot for the bridge railing, looking south.

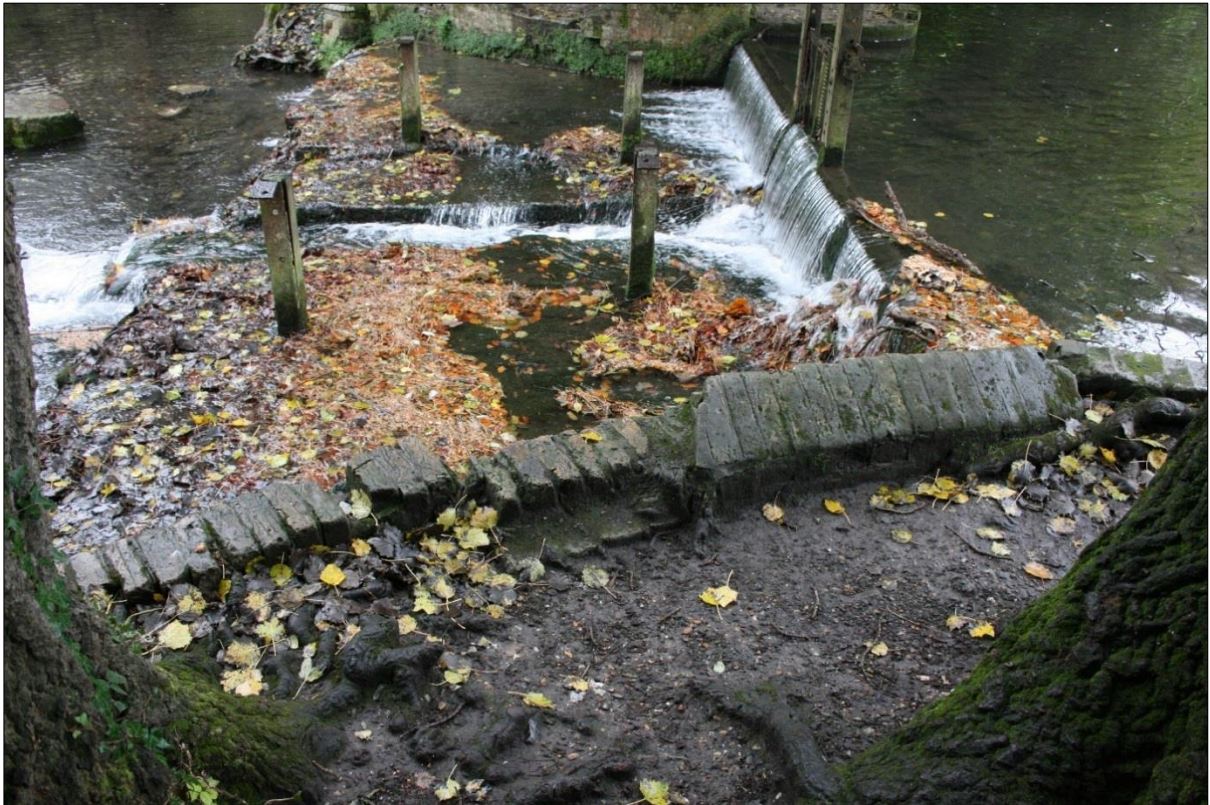
The bridge stanchions and weir, looking south. Note how the northern revetment has been trimmed to accommodate the bridge.

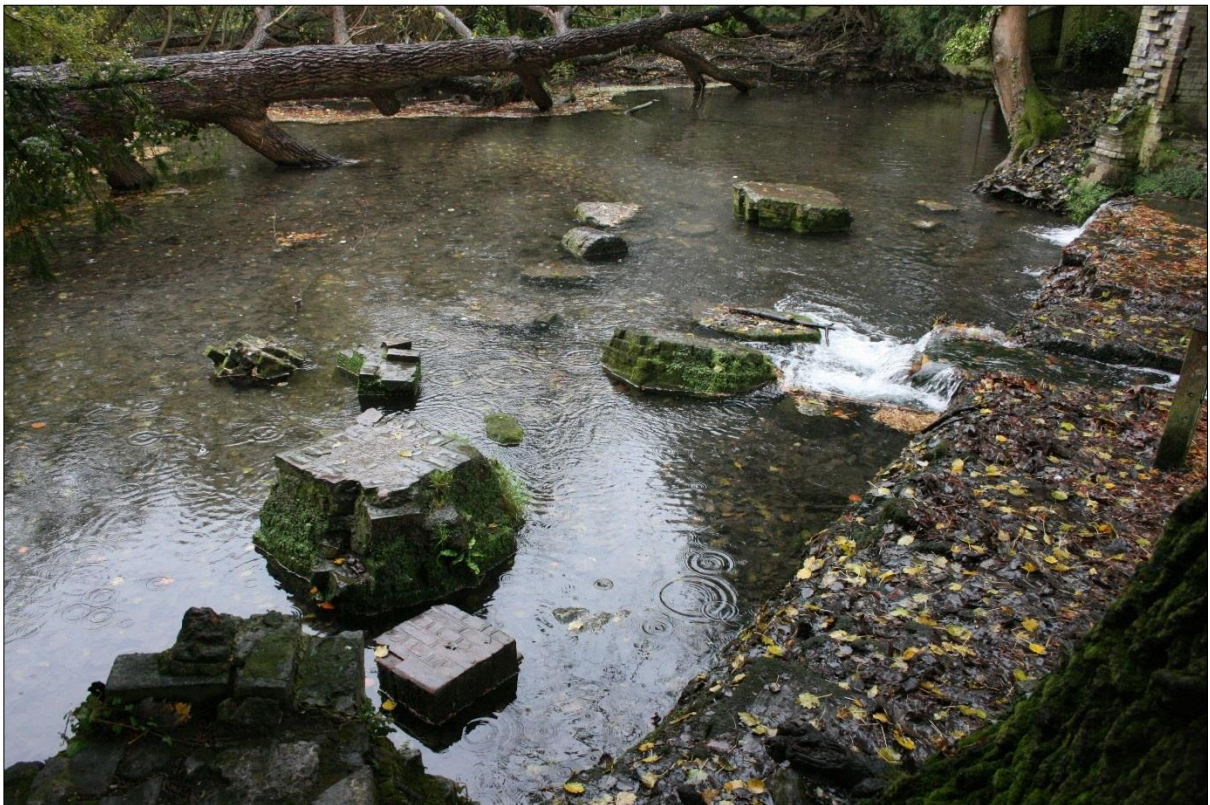
Rubble in the head of the millpond, looking south-east.

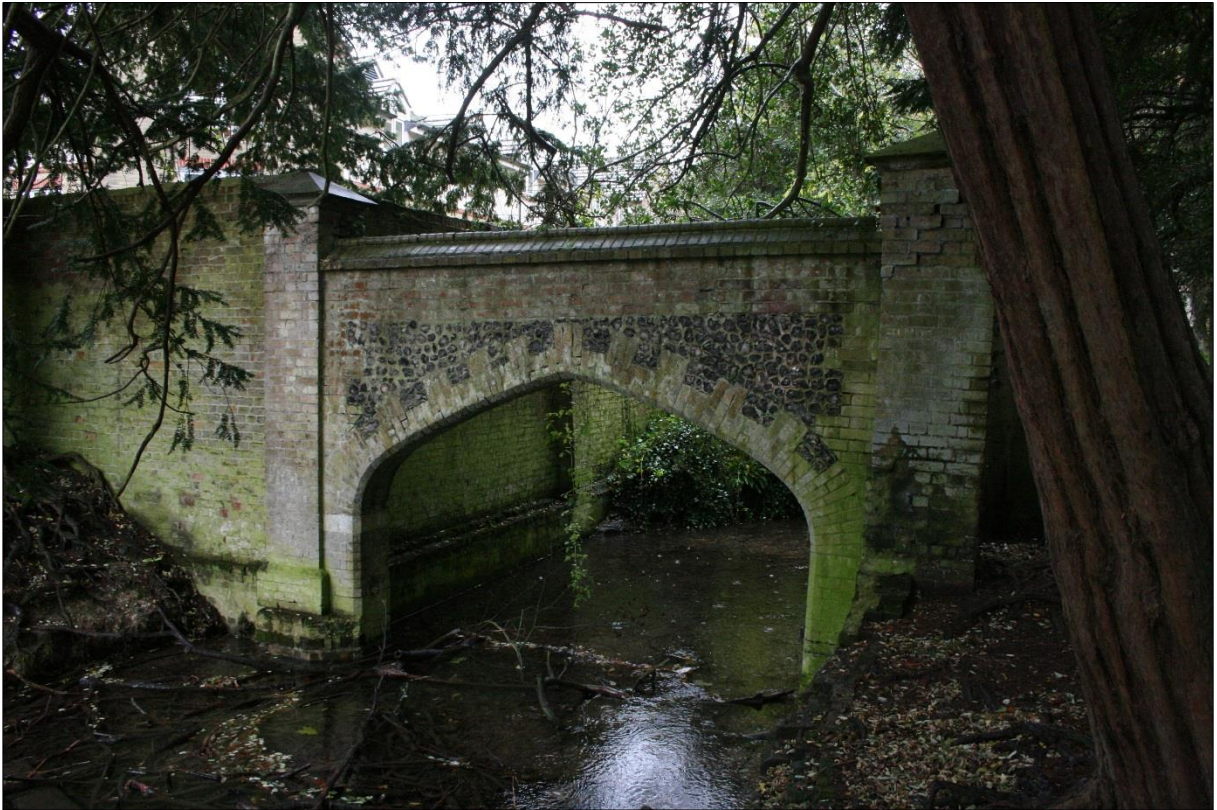
The arch adjoining the north-west corner of the Kitchen Garden, looking south.

The arch adjoining the north-west corner of the Kitchen Garden survives in much better condition. As noted above, this structure may have been listed, Grade II, in the 1970s ('arch across river'; TR 2843 6/112; NGR: 628908 143687), or this may have been the similar arch, over the northern branch of the River Dour, which has since fallen.

The arch is flanked by two brick piers, surmounted by shallow pyramidal stone caps typical of the Kearsney Abbey boundary wall. The western pier is keyed to tie it into the continuing boundary wall northward. The depressed, four-centred arch was turned as long and short chamfered 'voussoirs,' formed in gauged bricks, like those across the foot of the lake. The top of the wall comprises several courses of brickwork, surmounted by a roll-moulded brick coping, like the rest of the wall. Here, we can see that the intramural elevation of the arch is wholly of brickwork – narrowing toward the top of the wall. Pairs of pintles for the gate closing this archway survive in each jamb, supported by Portland-stone blocks.

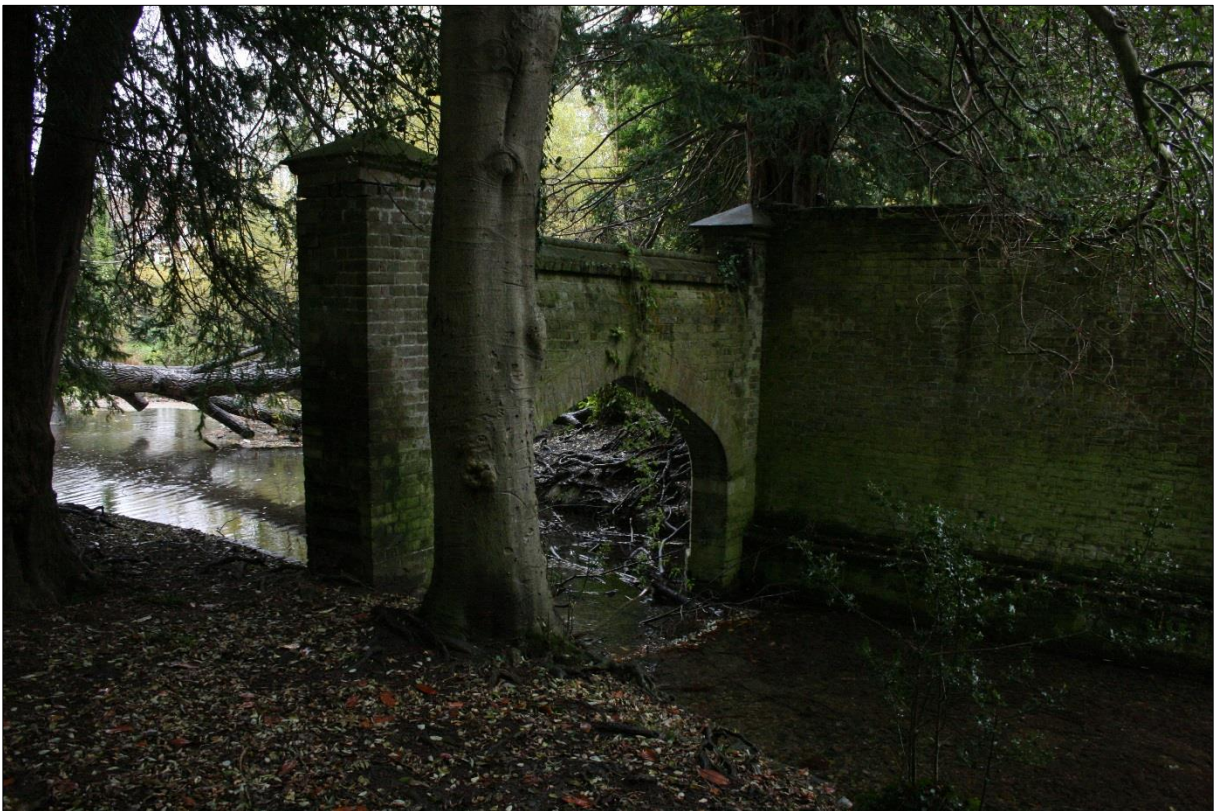
The arch, looking north-east.

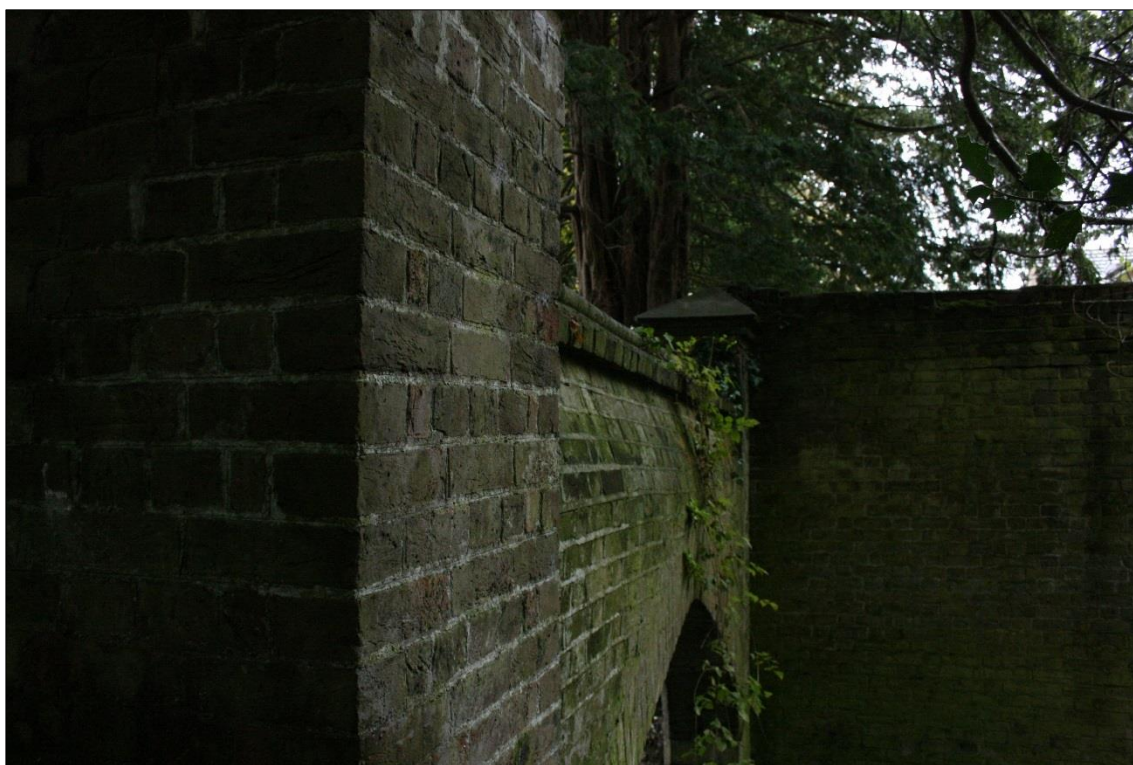
The top of the brick rear elevation of the arch, looking east.

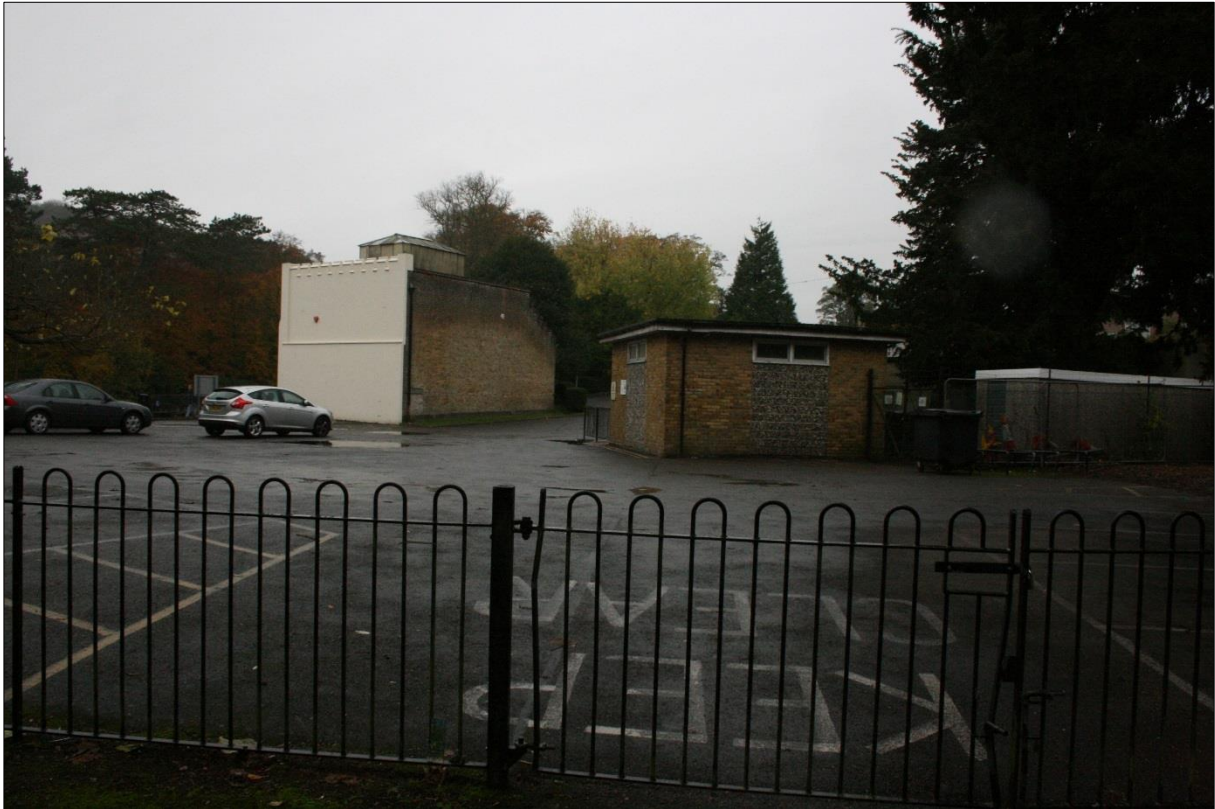
The site of the former Kearsney Abbey mansion, looking west.

Little of the fabric of the Kearsney Abbey mansion survived its piecemeal demolition during the course of the 1950s (see above: Section 2.9). Part of the rear wall of the service ranges survives where it coincided with the Alkham Road boundary wall: this stretch is entirely of brickwork, and lacks the usual roll-moulded coping. Footings also survive of the east elevation of the drawing room, at the south end of the east wing, including the York-stone sills of the french casements. Fragments survive of the mosaic-tiled terrace adjoining the drawing room – possibly a late nineteenth-century addition to the fabric.

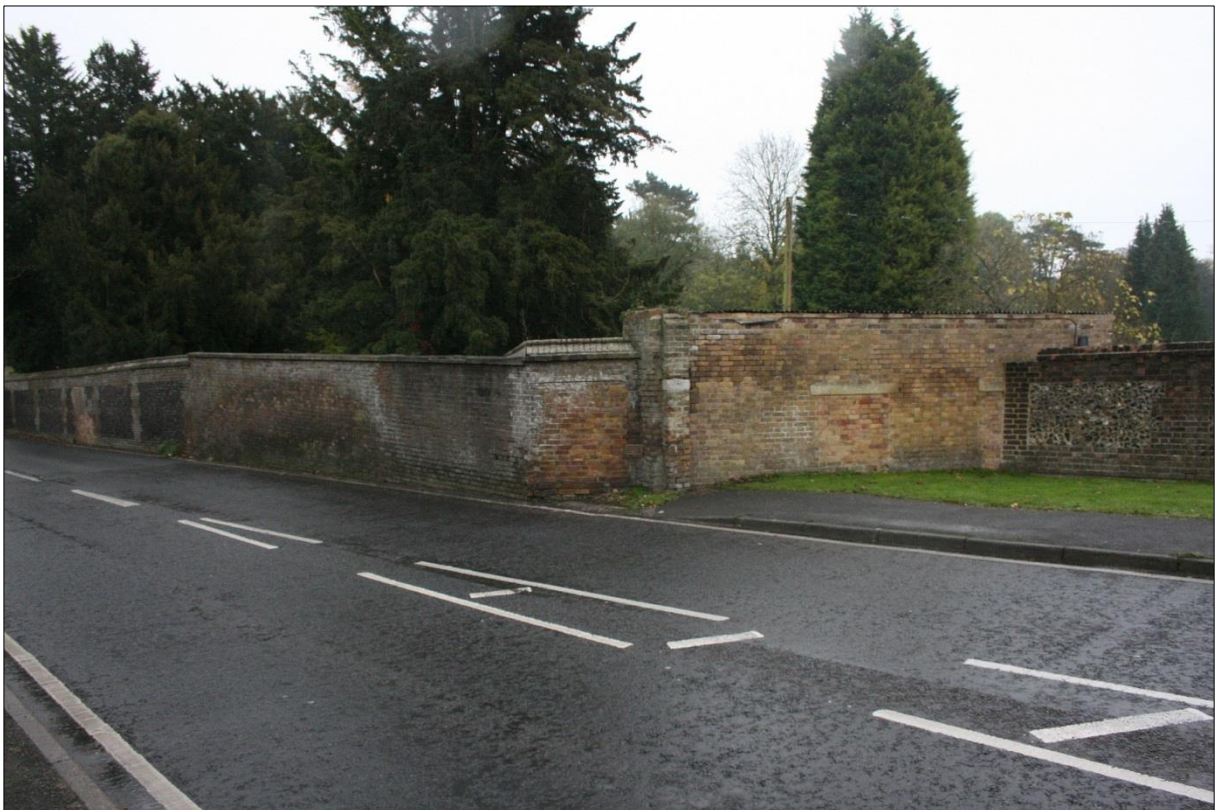
The back of the early nineteenth-century service ranges in the northern boundary of Kearsney Abbey, looking south-east.

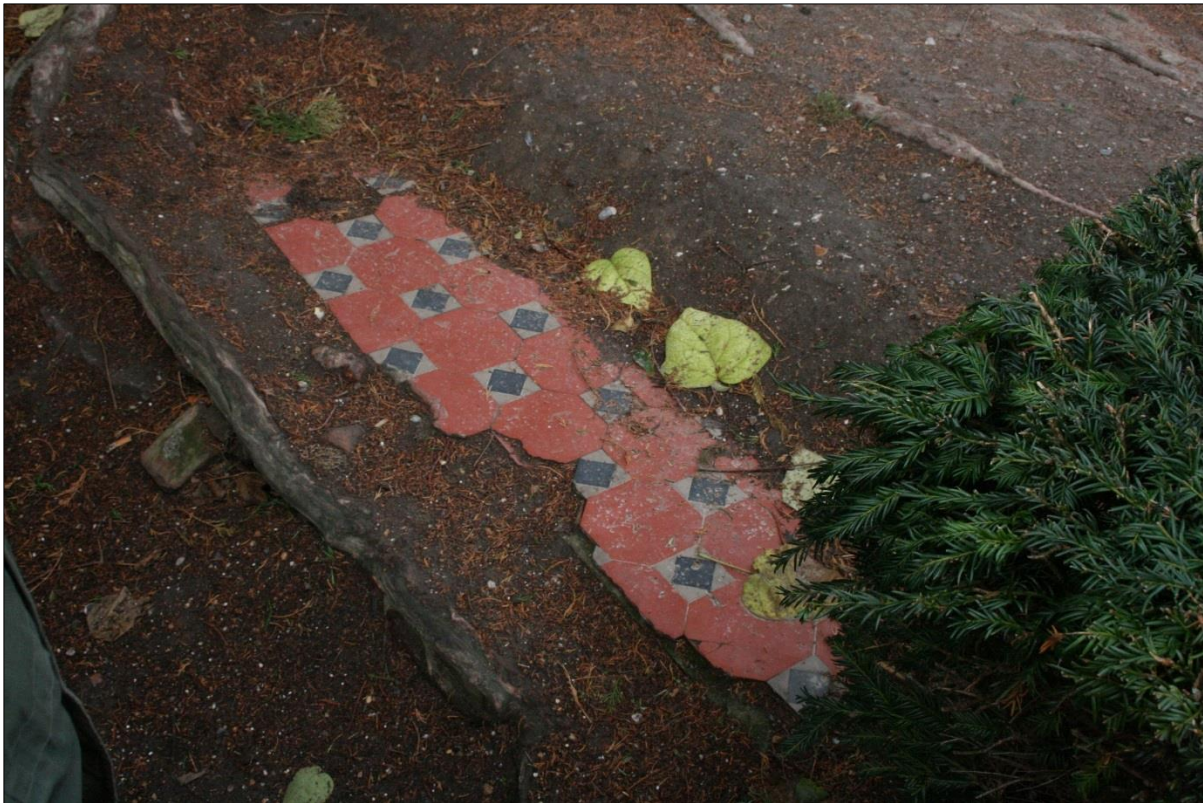
Part of the mosaic-tiled terrace adjoining the east wing of Kearsney Abbey, looking north-west.

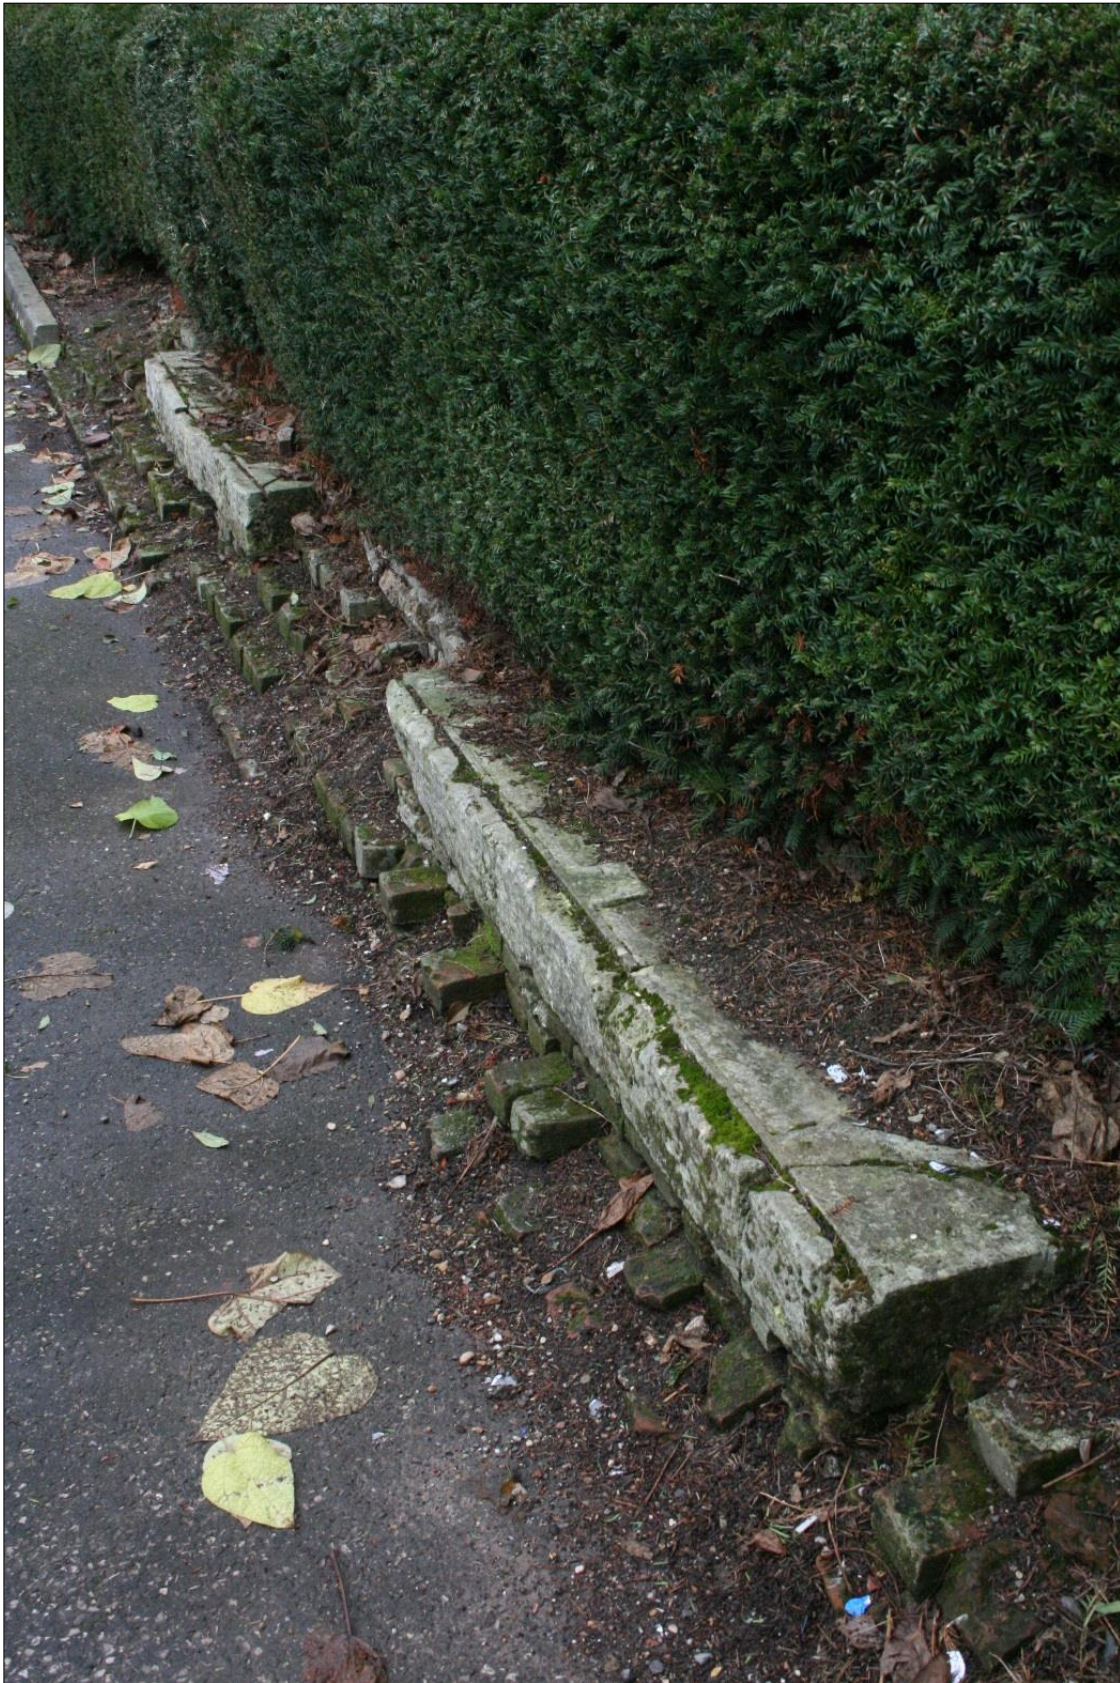
York-stone sills of french casements in the east elevation of the former drawing room, looking north.
