HISTORIC STRUCTURES AT KEARSNEY ABBEY, RIVER, DOVER

Revised December 2016

The present historic building survey was commissioned from Canterbury Archaeological Trust (CAT) by Jon Winder, Kearsney Parks Project Manager for Dover District Council (DDC), in November 2016. It is intended to provide a record of several historic structures affected by proposed enhancement and restoration works at Kearsney Abbey Gardens, Alkham Road, Dover (NGR: 628740 143795).

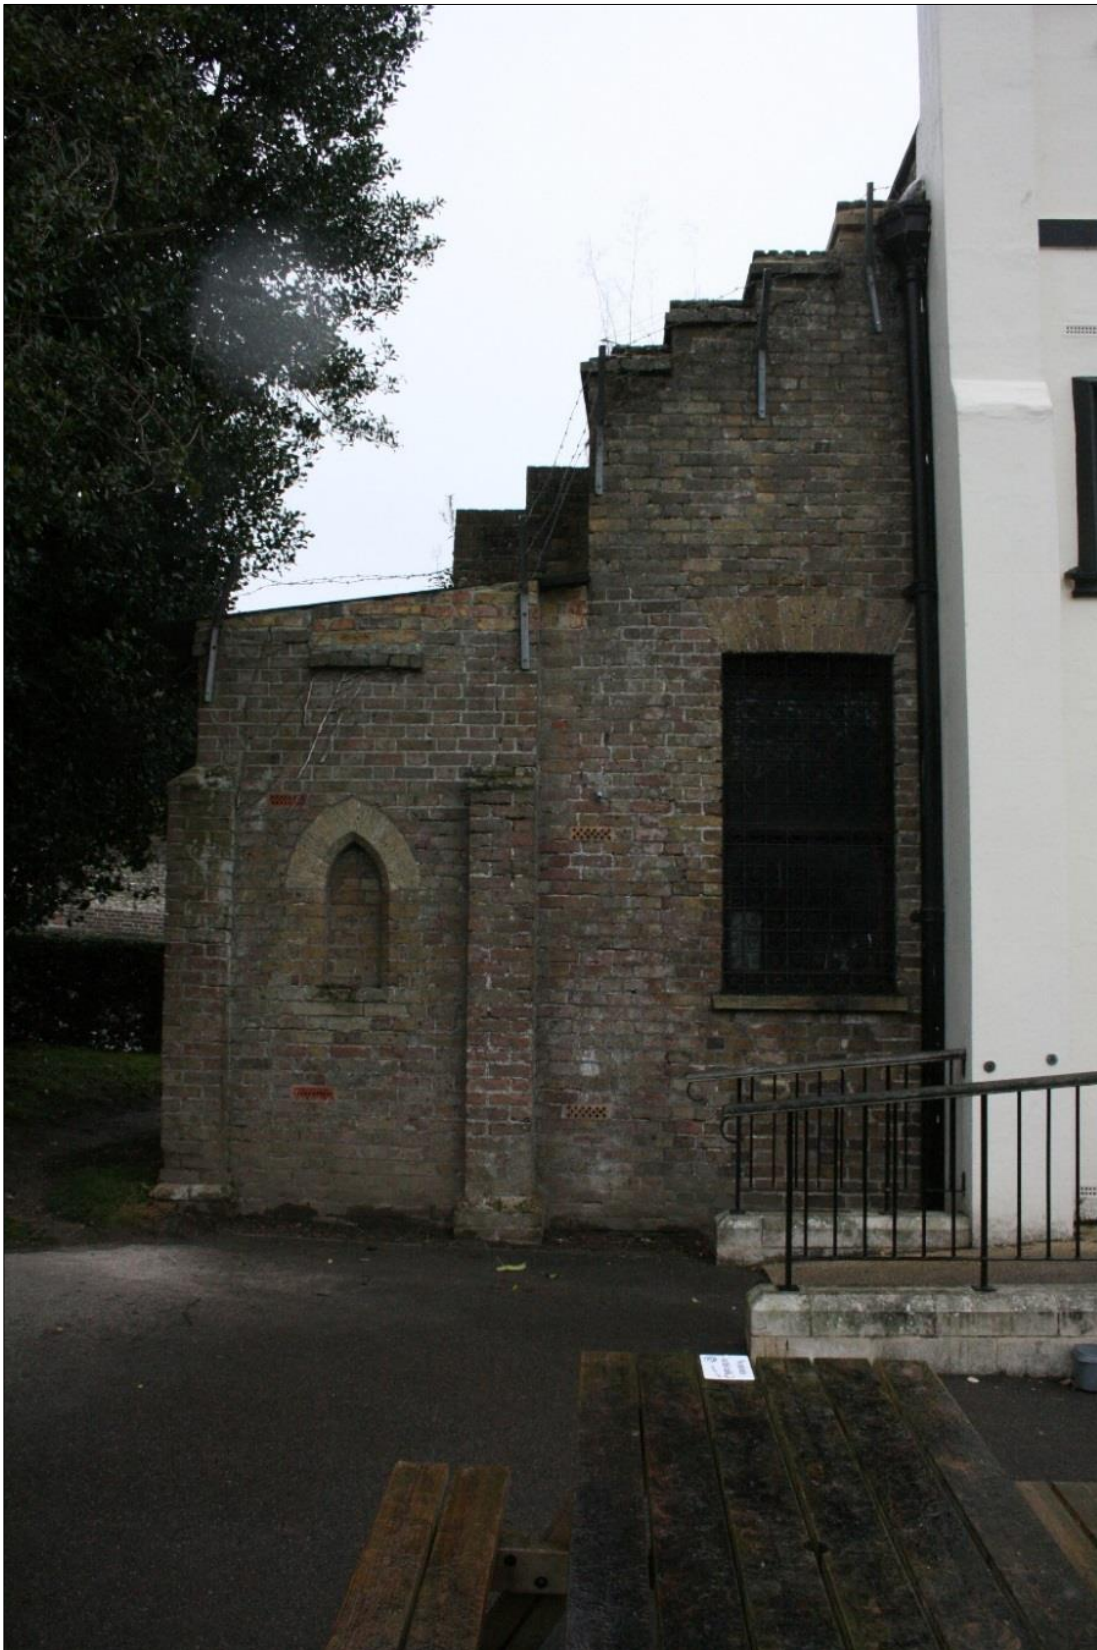
Remains of an early nineteenth century service yard building incorporated into the late nineteenth-century gentleman's lavatory adjoining the billiard room, looking north.

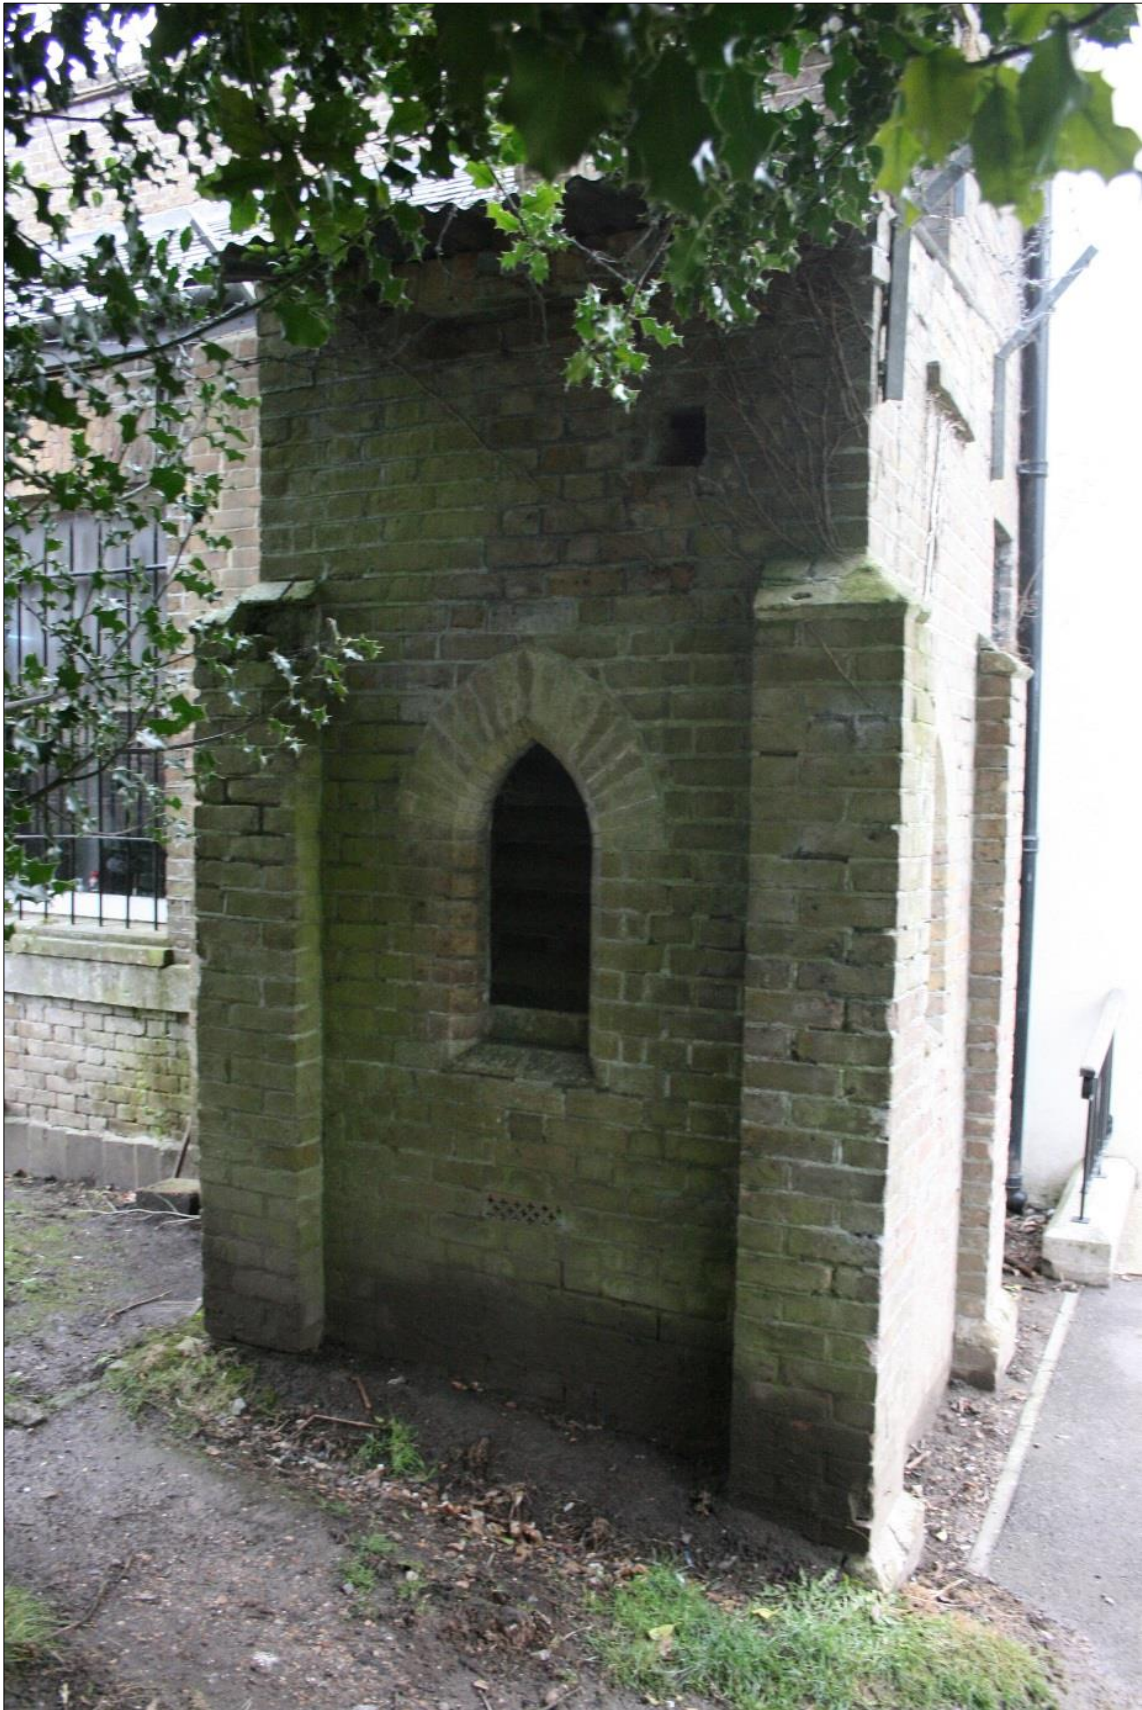
contain a small, lancet window, chamfered all round; that to the west houses a louver, that to the south has been bricked-up.

The turret, looking north-east.

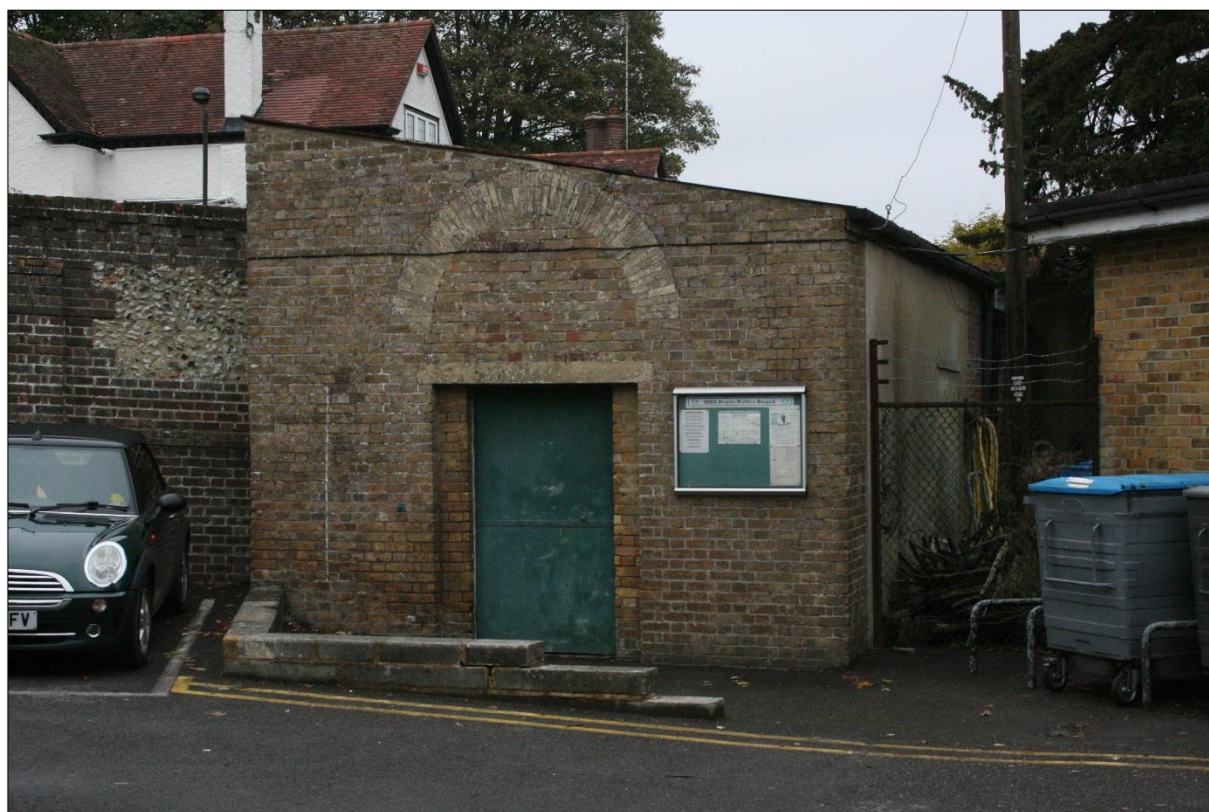
The surviving early nineteenth-century ‘shed’, looking north.

This surviving outbuilding is shown on the tithe map of 1838, and is probably original to the house. It originally stood wholly within the grounds, but the stretch of boundary wall to the west was rebuilt to the south of its original line in the mid twentieth-century, providing a footpath along this side of the Alkham Road, and now abuts its west wall.⁵⁸ The 1907 estate sales catalogue refers to ‘coal, wood and oil sheds’ and a ‘box room,’ outside the service wing of the house, and this may well have been one of those structures. It has evidently been through many alterations, and we have not examined it in detail for the present report. It may originally have been gabled, north and south, but now has a single-sloping roof. The large round-headed door aperture in the south wall has been bricked-up with a smaller doorway under a concrete lintel. The east elevation has been rendered where it was severed from the adjoining service ranges to the east, during the late nineteenth-century, to improve the driveway at the north entrance to the house.

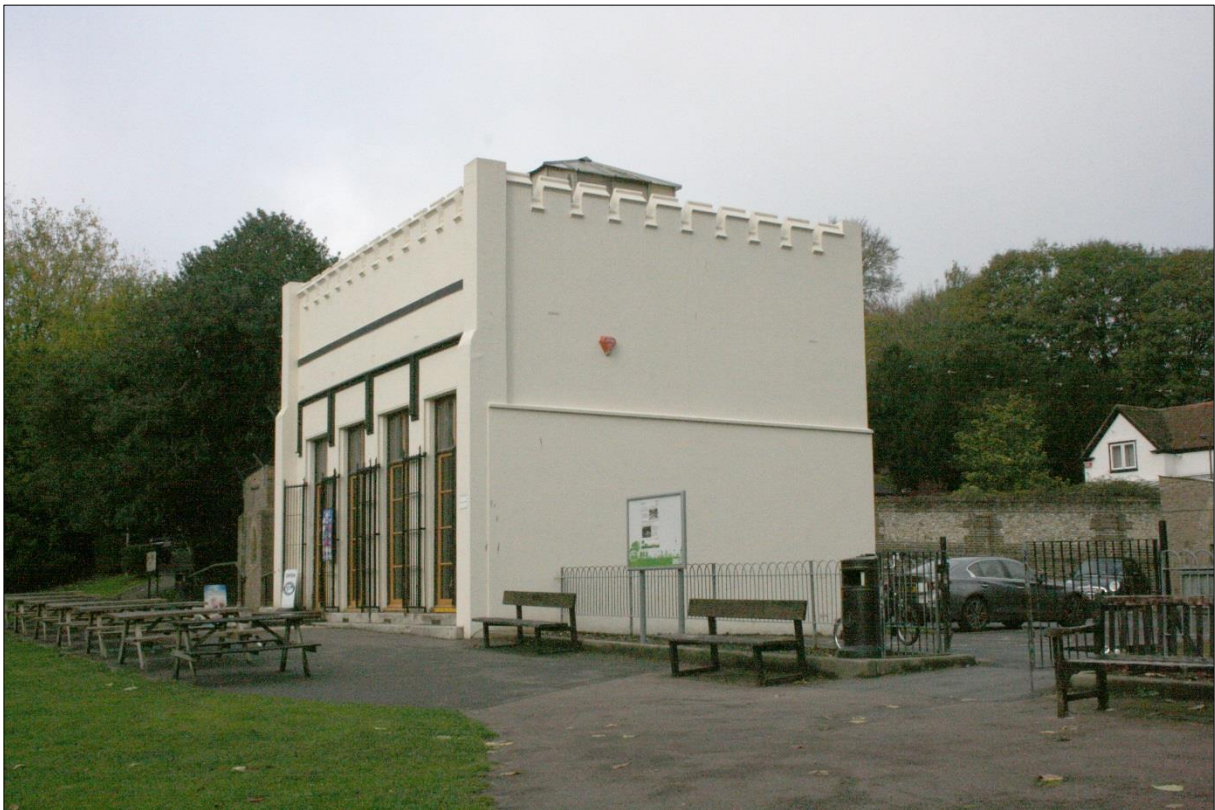
The former billiard room, from the south-east.

billiard room in summer. It is not clear whether these were original. The casements have been replaced at a recent date, and fitted with iron grilles.

Above these casements were a stringcourse and crenelated parapet.

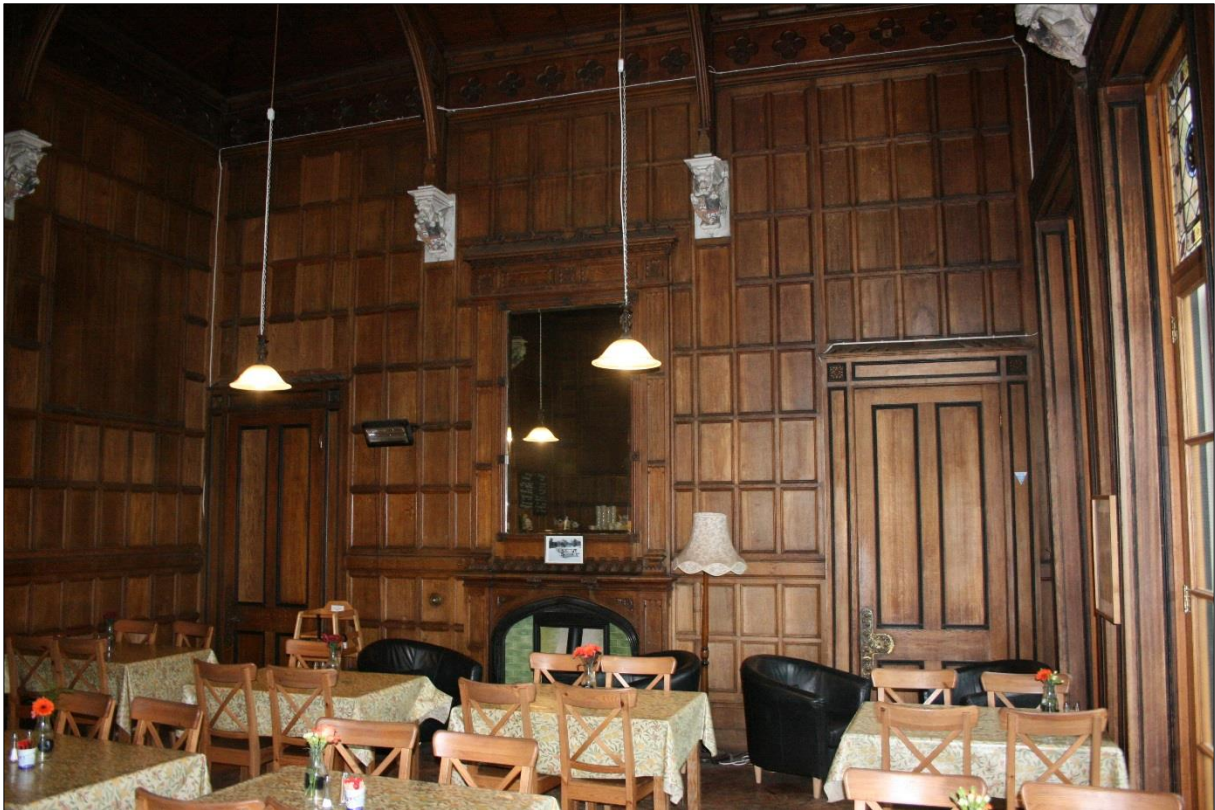
The billiard room interior, looking east.

The original herringbone parquet floor survives. Historic photographs attest alternating bans of darker and lighter woodblocks – it is hard to tell whether these were of different timbers, or merely stained.

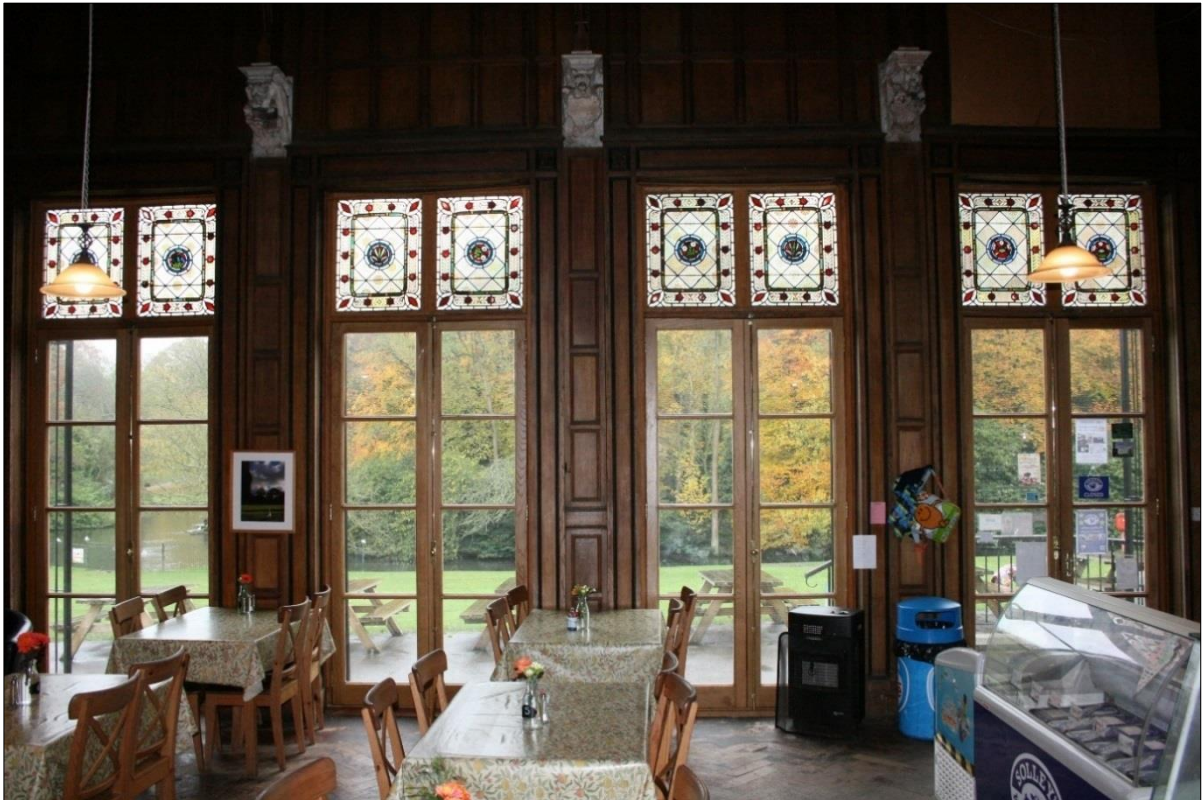
Transom-lights over the french casements are filled with painted glass by Brown, Reynolds, and Boreham, of Hunter Street, Brunswick Square, London. These, as noted above (Section 2.4), can be dated prior to October 1877,

agreeing with our date of c1876 for the room as a whole. Central roundels depict various wild flowers.

The south wall of the billiard room.

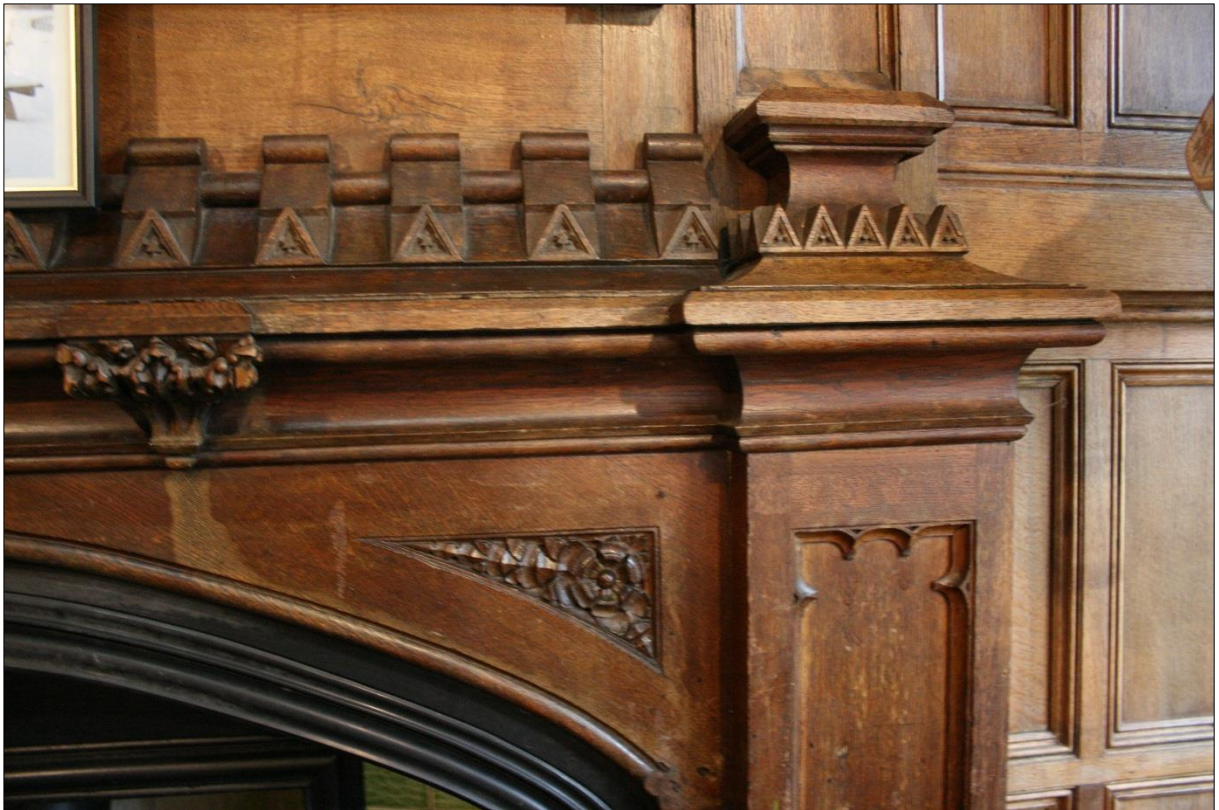
The fireplace, in the middle of the east wall, was a richer mixture of gothic, classical, and modern features – albeit to rather weak and nonsensical effect. The hearth is spanned by a moulded four-centred arch of what appears to be marble stained black. The spandrels are carved with roses, and the jambs have cusped sunk panels. The mantle is boldly shaped, above and below; it ‘supported’ by miniature gothic capitals, and surmounted by crenelations with pediments, filled with trefoils, on the faces of the merlons. The overmantel contains a large mirror, surrounded by a cusped-panelled frame, with shields in the small square panels at the corners and in the middle of the head. There is a curious moulding in the cornice, comprising a thin roll moulding within a larger hollow, with thin, ‘toothed’ annulets quite widely spaced along the roll; the cornice is surmounted by Tudor-flower brattishing.

Castellated gothic detail of the billiard room fireplace.

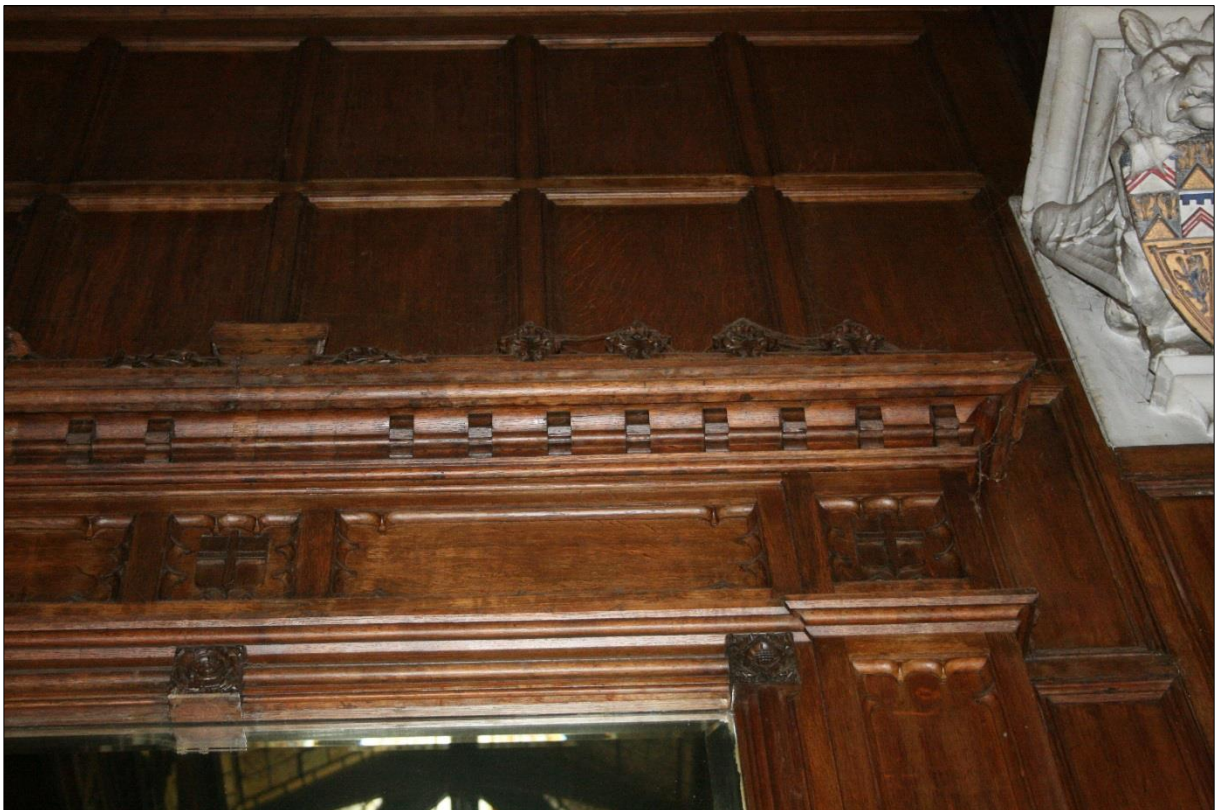
Detail of the head of the overmantel.

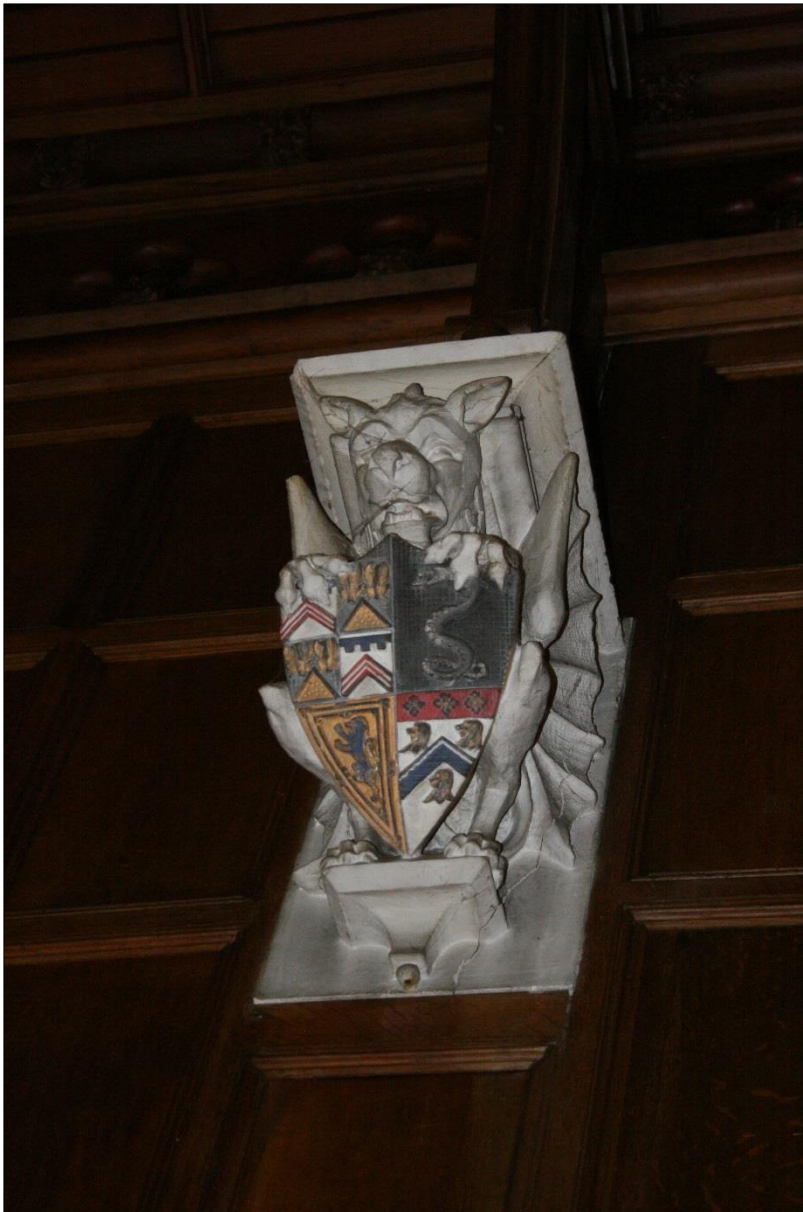
The eastern corbel on the north wall.

The arched roof braces are supported by Portland-stone(?) corbels, toward the top of the walls, finely carved with shields, clasped by monsters.

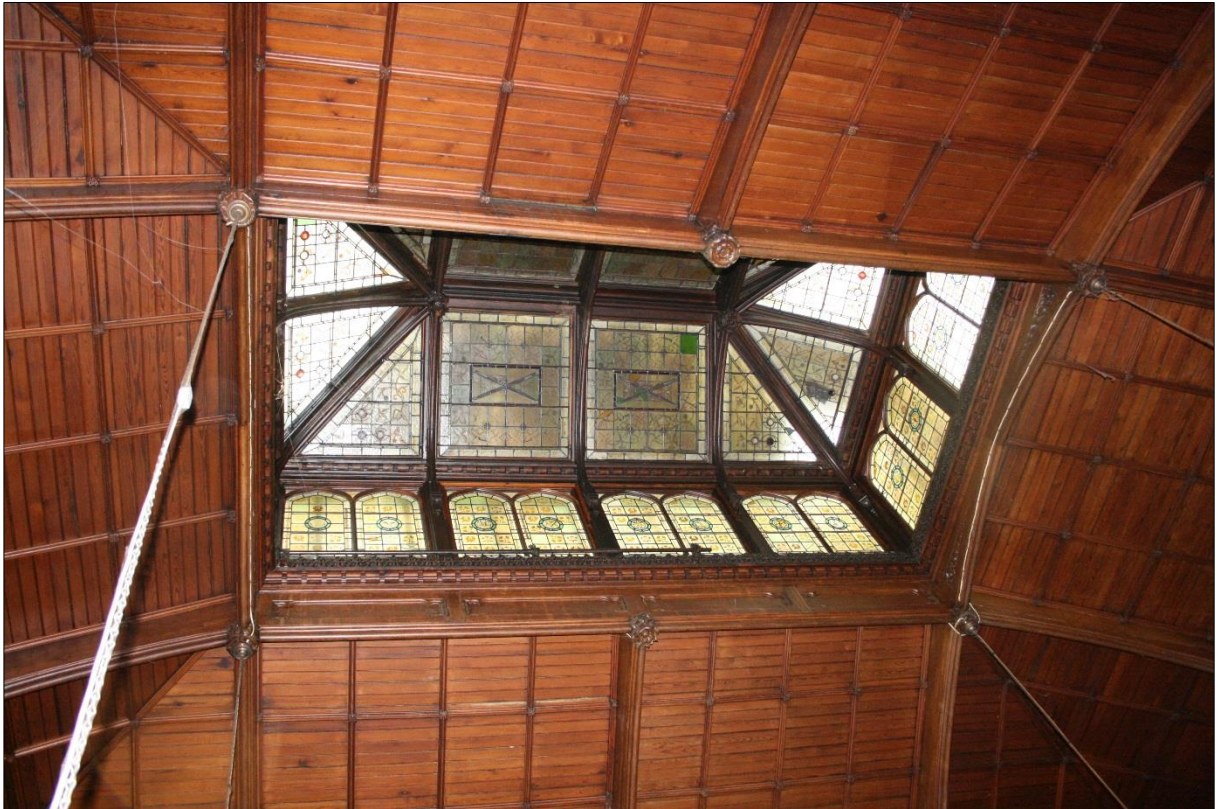
overmantel. The small, paired, four-centred-arched windows – with tiny glazed spandrels, are filled with stained glass, again with flowers in the central roundels, and doubtless by the same workshop. They have delicate, moulded frames, which continue upwards – through a billet moulding along the window-heads – to generate a miniature hipped roof with its own small rose-bosses. The glazed panels on the long sides depict pairs of billiard cues, crossed; the small triangular panels at the hips incorporate triplets of billiard balls (two white one red), amid (off-the-peg?) arabesques.

Detail of the roof and lantern, looking north.

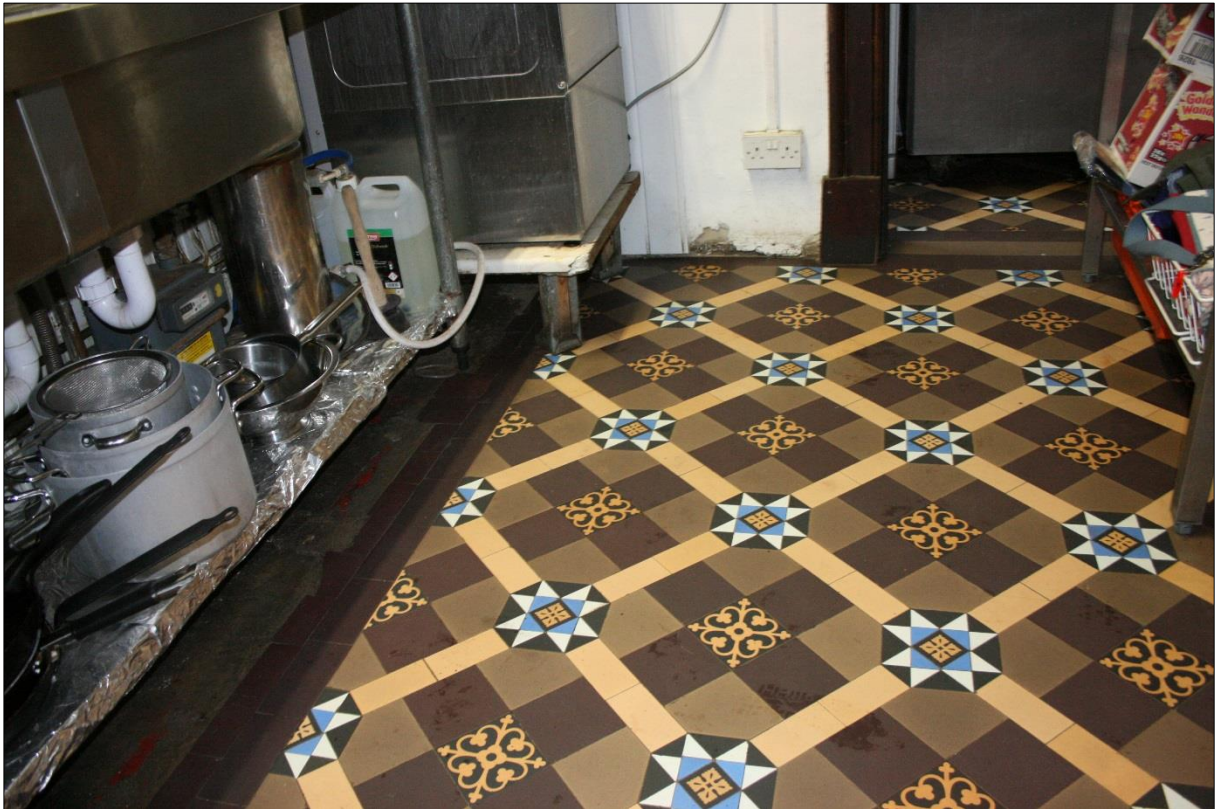
As we have seen, the billiard room will have formed the centrepiece of the 'male domain' at Kearsney Abbey, hence only a gentleman's lavatory was required. This was provided with a mosaic-tiled floor and a timber ceiling. A compartment at its northern end will have housed a water closet, and there will have been washbasins along the west wall and urinals on the south. This room is now in use as a small kitchen.

The floor of the gentleman's lavatory, looking north.

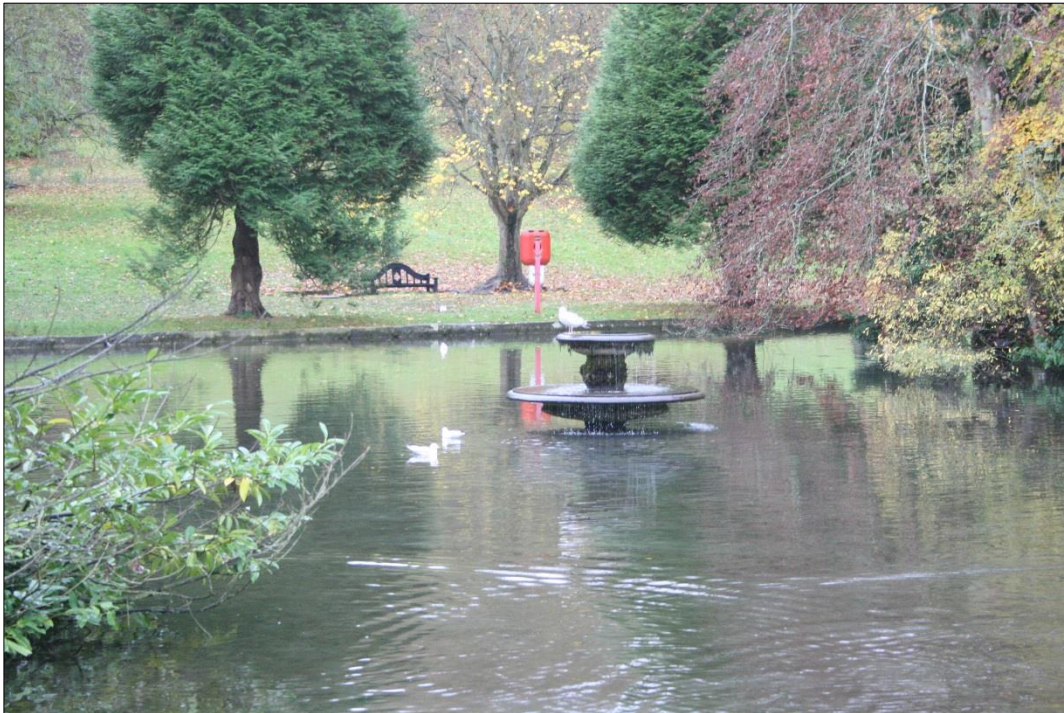
Fountain in the Abbey Lake, looking south-west.

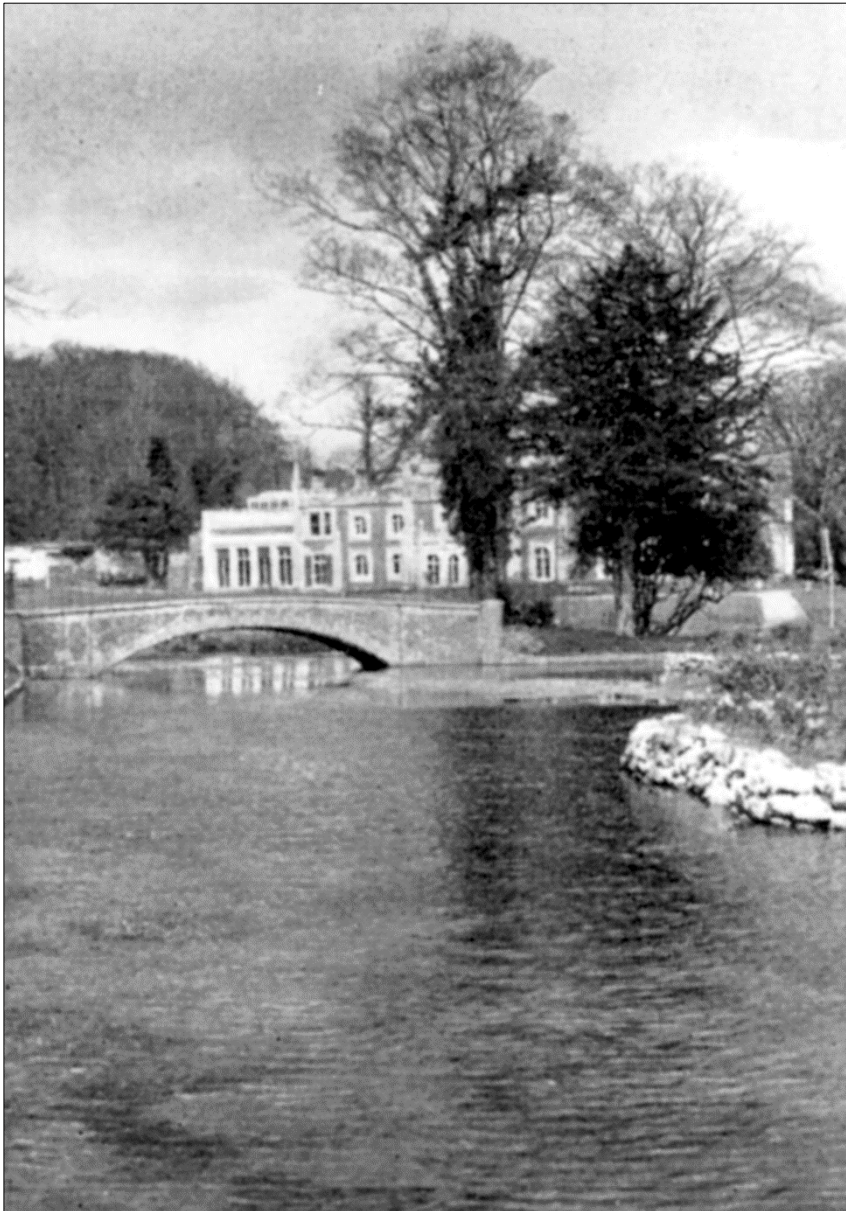
Detail of a mid twentieth-century photograph of the bridge and Kearsney Abbey

About mid-way across the grounds, the lake contracts, and is bridged by an ornamental footbridge, again, listed Grade II ('bridge'; TR 2843 6/65; NGR: 628825 143698). This is very much in keeping with the other early nineteenth century fabric, and may well have been part of the original scheme. The bridge is of a single broad, elliptical span, turned in the usual pinkish yellow brick, with knapped flint in the spandrels and wingwalls, and a very low, brick parapet, coped with stone. The chamfered, brick-built voussoirs alternately project – akin to banded rustication – or point outwards equilaterally into the spandrels. The arch is flanked by pilasters, formed with rusticated brick quoins, which define the wingwalls. The wingwalls terminate in octagonal, brick piers, slightly higher than the

The present ornamental railings do not feature in mid twentieth-century photographs of the bridge, and may be modern – albeit perhaps replacing one that had been lost. They have seen more than one phase of repair; the original panels seem to have been filled with criss-cross wirework.

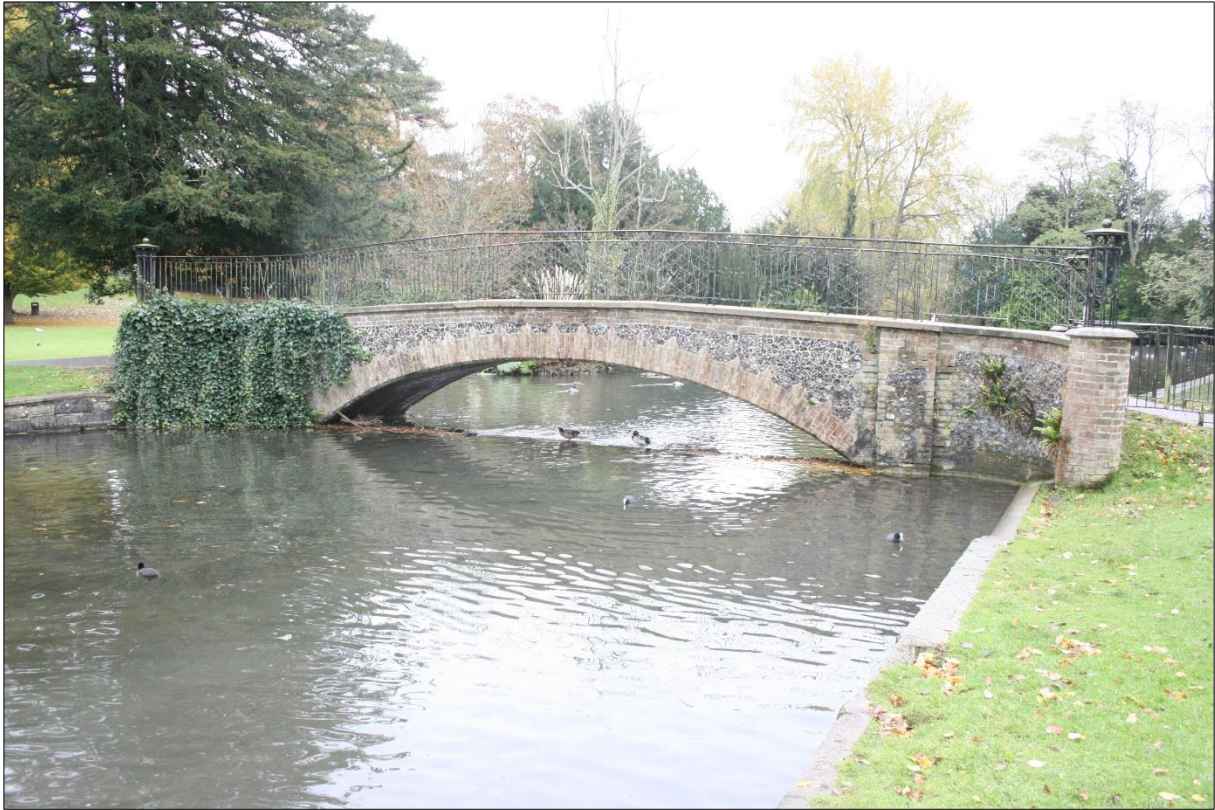
The bridge, looking west.
