Site Survey

4.1 Landscape and Visual Appraisal

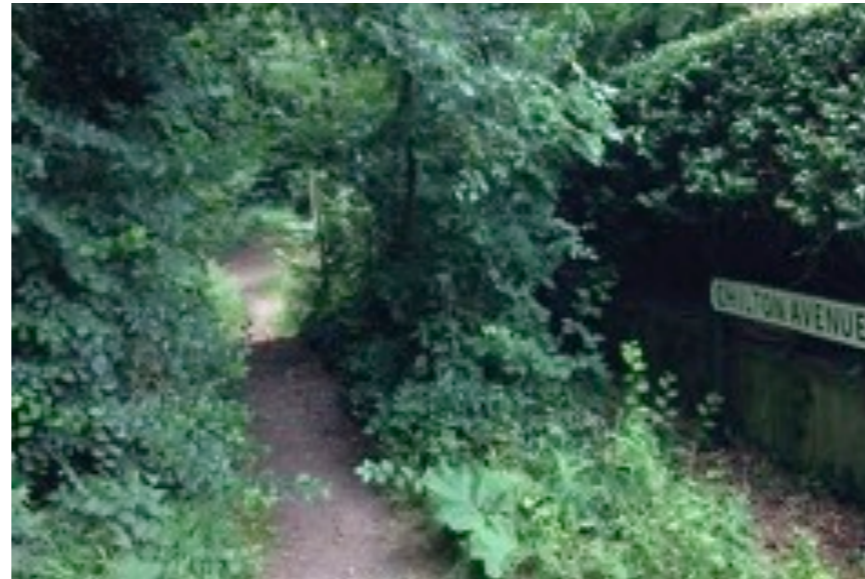
Plate 4.6: Chilton Avenue entrance

This is a strong desire-line from Chilton Avenue housing up to Coxhill Mount. This is an informal entrance, probably mostly used by local people, with no indication that a visitor is entering the park.

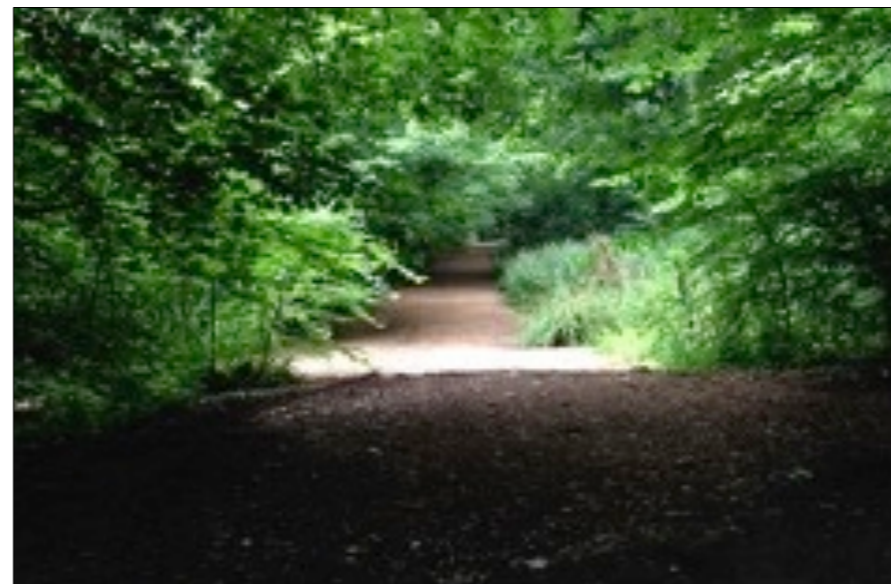
Plate 4.7: Abbey Road entrance

Sections of the Abbey Road boundary with Kearsney Abbey park are unfenced, and the gap leading to the east-west track across the parkland is used as a park entrance. This is also an informal entrance and there is no signage or way-marking.

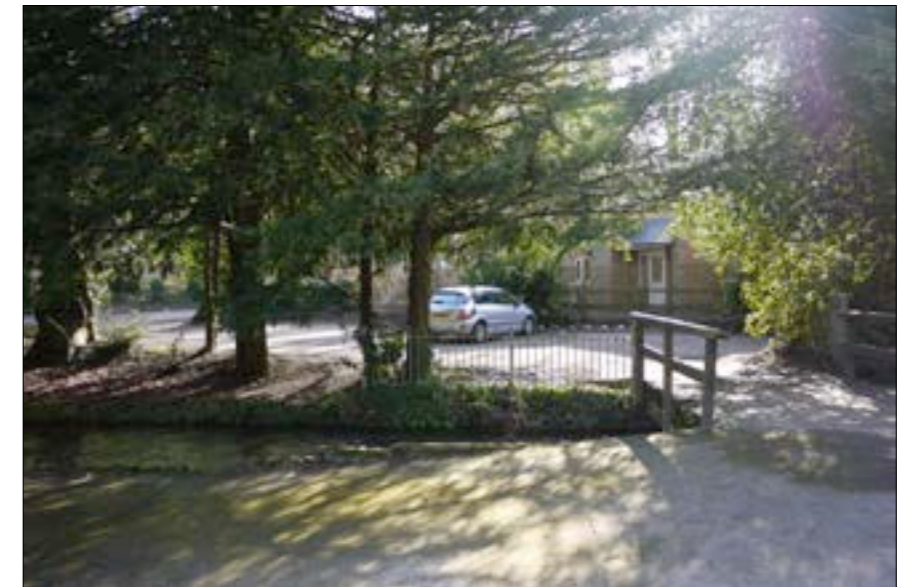
Plate 4.12: Russell Gardens car park

This car park offers a level hard surface, however the parking bays are not marked out. There is level pedestrian access, via a wooden bridge,

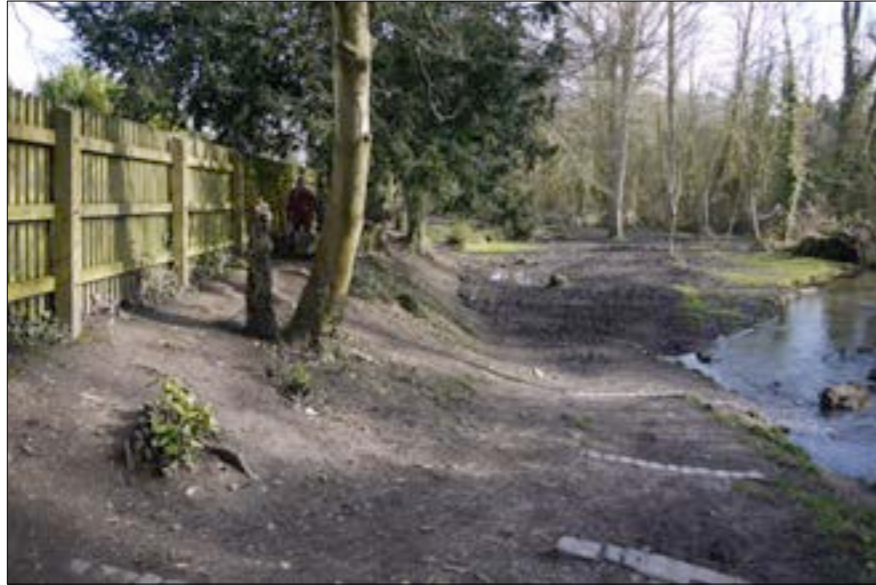
Plate 4.13: Path to River paper mill

This path connects the Minnis Lane entrance into the main body of Kearsney Abbey park. It is compacted earth, and has been improved with bark chips in places. It is worn wide, with no definition of edges.

Near the entrance from Lower Road, the levels become more uneven and there are cobble steps set out in a semi-circular pattern. Access across this area is difficult for most users, exacerbated by the steep cross fall towards the river. The lower levels of the path flood. Adjustment of ground levels and a surfaced path in this area would provide a level route from Minnis Lane to Alkham Road and open up access to the mill ruins to visitors.

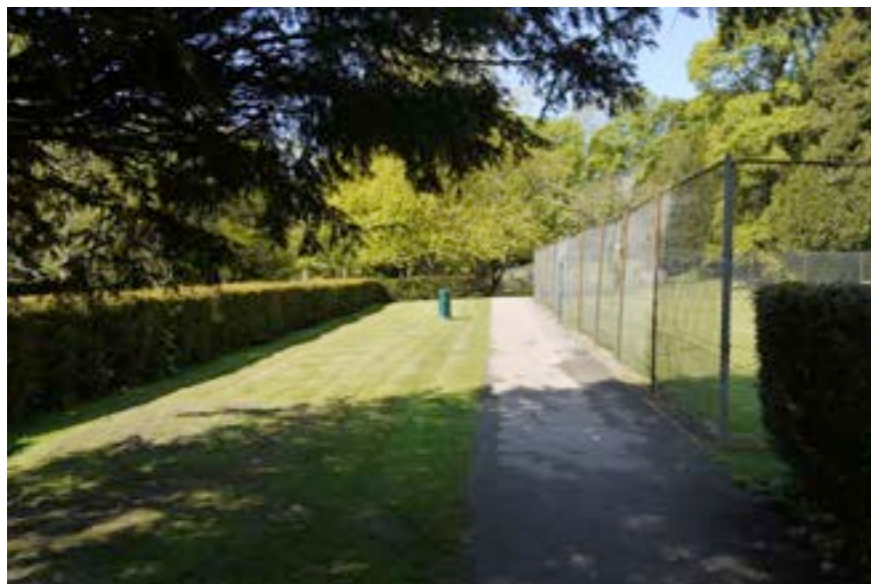
Plate 4.18: Tennis court path

The path alongside the tennis courts offers good access for most users, with an even asphalt surface. However, at the eastern end, it narrows to 1200mm wide at the entrance, which is too narrow to allow a wheelchair or a pushchair to pass another person.

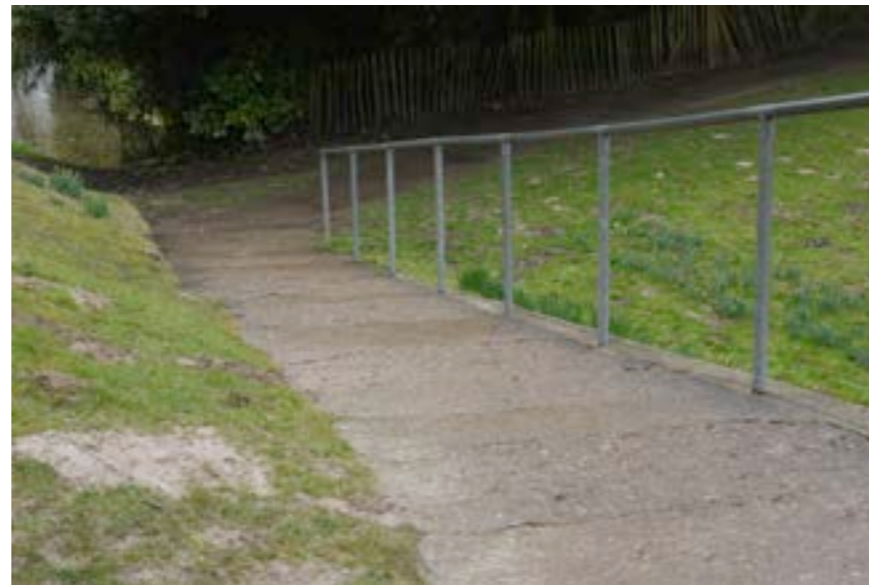
Plate 4.19: Steep path link

The two ramps are both steep; the eastern one is very steep and long. It has a handrail on one side for part of its length but is too steep for too great a distance to provide inclusive access. It prevents people who are unable to manage the gradient and distance, from completing a circular route along the bottom and top terrace.

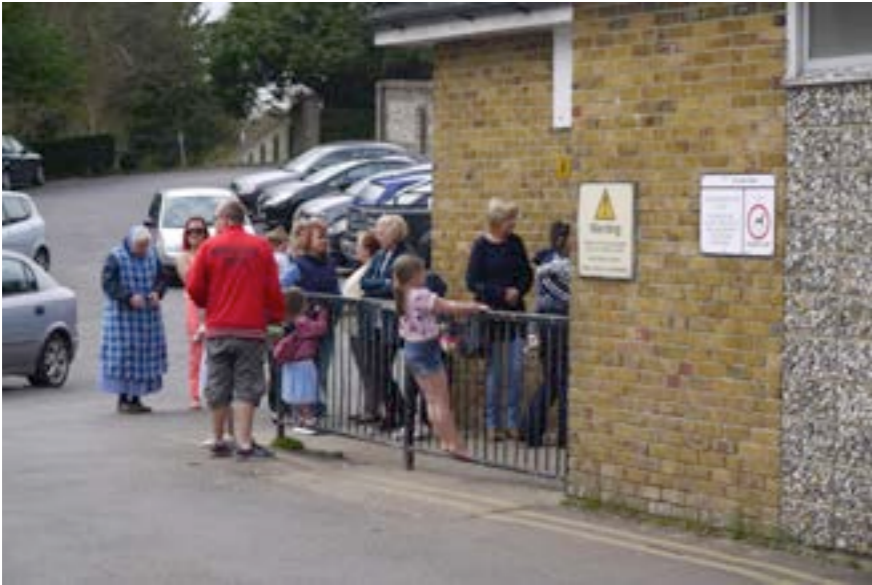
Plate 4.22: Kearsney Abbey toilets

The WC block at Kearsney Abbey serves both the Abbey grounds and Russell Gardens. It is located in the Cafe car park. The facilities include male, female and accessible WCs. The male and female facilities lack visual contrast between the cubicle walls, doors and wash hand basins.

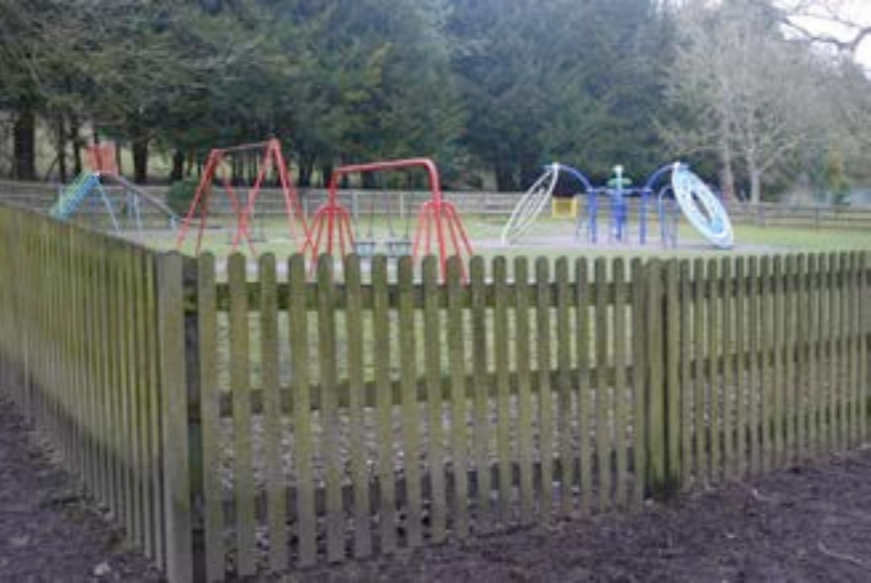
Plate 4.23: Russell Gardens playground

Access into the playground is via firm surfaces with wide, easy to use gates in contrasting colours. Seating within the play area has space for a wheelchair user to sit alongside and the site is reasonably level. The play equipment does not include equipment accessible for children with a disability although there is space to add this.

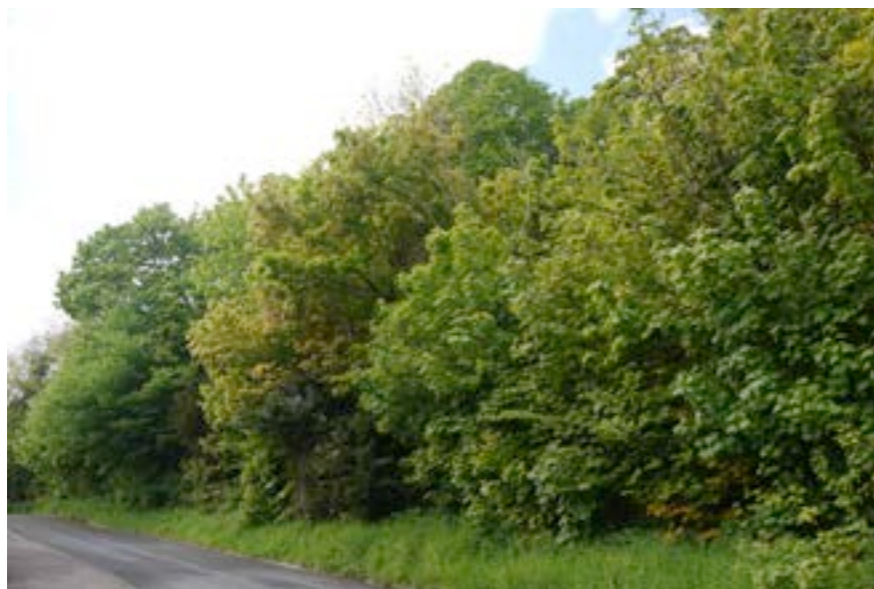
Plate 4.29: Coxhill Crescent boundary scrub

Along Coxhill Crescent, the park boundary is unfenced, but is also fairly impenetrable, comprising a steep bank covered in maturing scrub vegetation.

Local users have created occasional paths up the steep bank into the woodland.

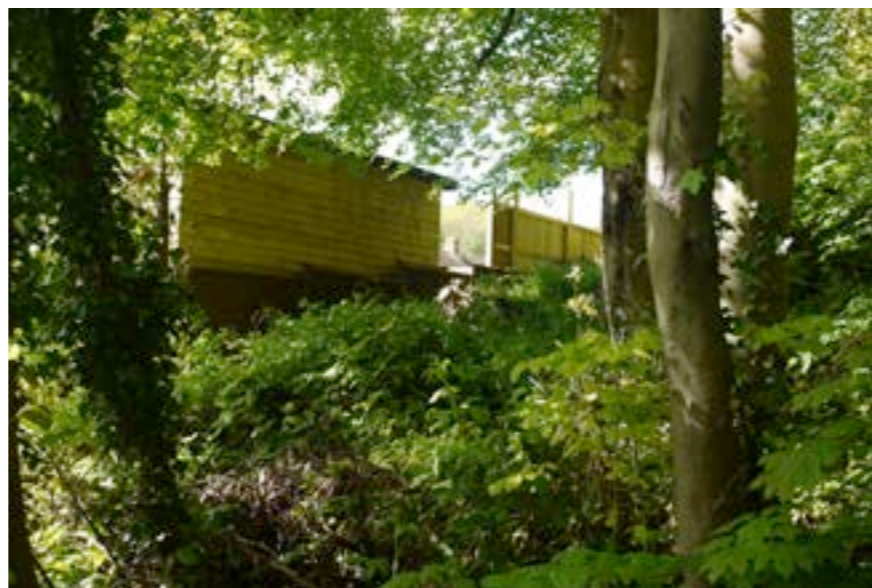
Plate 4.30: Rear garden fencing along Coxhill Gardens

Running along the backs of Coxhill Gardens, there are various fences maintained by residents. The visual diversity of these differing styles is generally hidden by dense woodland. Some private garden entrances have been created and land-take for garden use is happening.

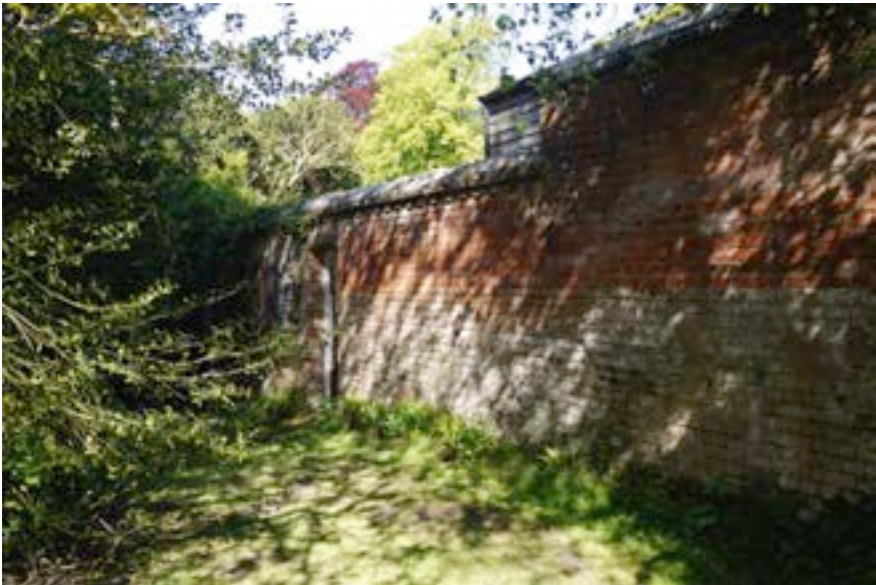
Plate 4.35: B12 Wall of the old Kearsney Court walled gardens

This boundary brick wall of the former Kearsney Court walled garden is 2m or more high. There is still a gateway between the old walled garden area and the park, with the door hanging off its hinges. Clarity of responsibility for this wall – and the door – is needed.

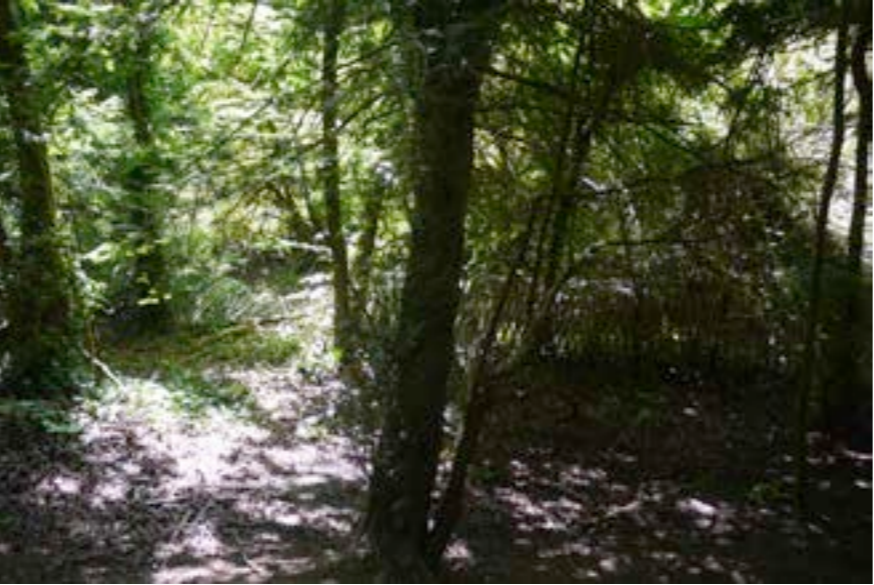
Plate 4.36: B13 Chestnut pale fence

Chestnut paling has been used along this boundary, to separate the public areas from the privately owned woodland around the bastion. The fence does not provide a secure boundary, and has been trampled to gain access to the woodlands; a desire line has been created, leading to the higher areas of park, towards Palmtree Hill Plantation.

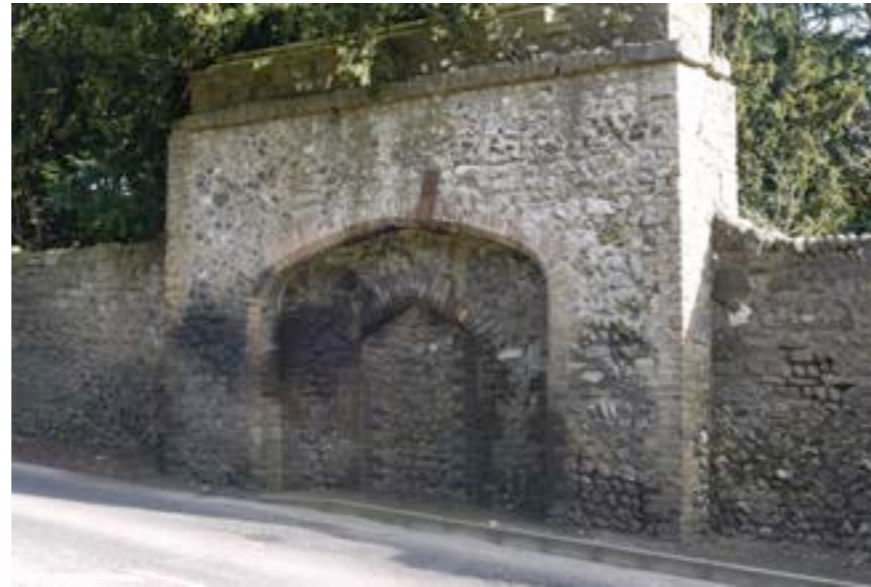
Plate 4.47: Part of the 'folly ruin' boundary wall

The sections of wall adjacent to the old mill (B1) are listed Grade II. They were created as mock ruins, incorporating the C16 Old Town Mill. They consist predominantly of flint and brick, with brick buttresses and some ashlar masonry at previous and present entrances. In-filled openings and entrances are identified by brick quoins and arches, which form decorative features, including the blocked Ogee and Tudor archways that form an impressive feature on the outside, Alkham Road face, of the wall (Plate 4.47).

Some areas of urgent work are needed around the mill ruins where repointing and recapping are needed to ensure the historic fabric does not deteriorate further.

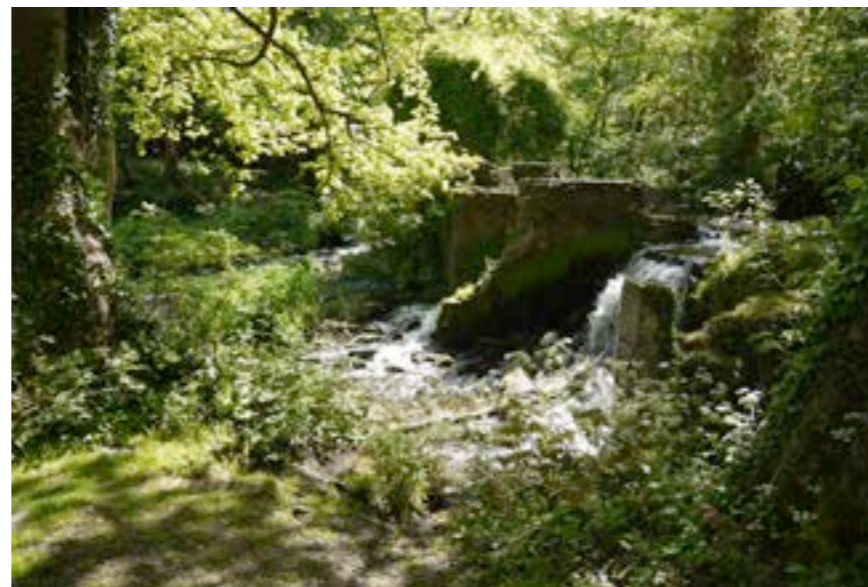
Plate 4.56: Remains of River paper mill

The remaining masonry that survives from the mill ruins is reasonably stable.

With vegetation growth and the erosion caused by the water course, these ruins will continue to weather over time. Regular monitoring of the taller segments of masonry is advised, and any remedial or stabilisation works needed should be carried out, to limit any risk to the public.

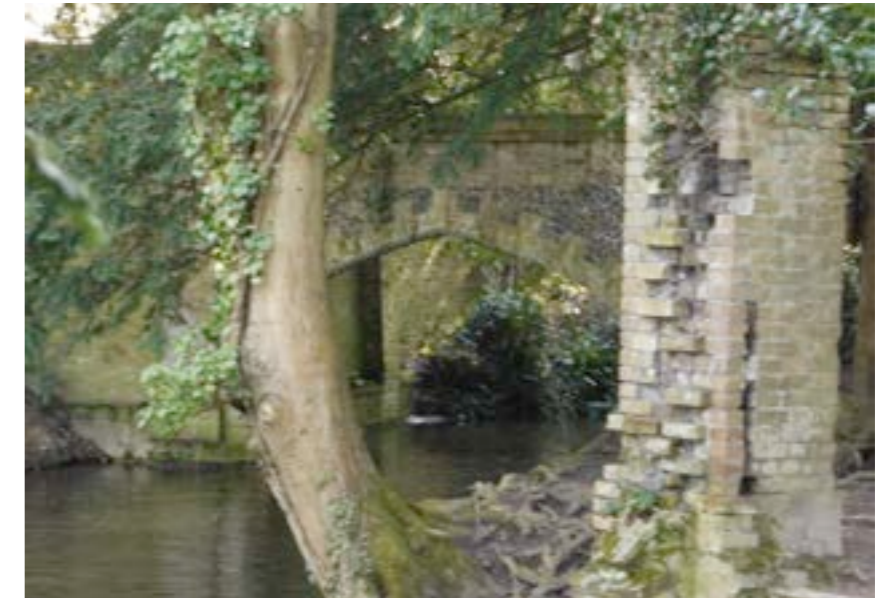
Plate 4.57: Archway

accelerated erosion of the bricks. This should be removed and repointing with a suitable mortar carried out. However, it may not be practical to remove the cement mortar if it is very much harder than the adjacent bricks, and a test patch should be done before carrying out any works.

The embankments adjacent to this arch are formed of brick and flint. The masonry in this area is also in need of repointing and consolidation. There is a large tree on the north embankment which has caused movement to the wall.
